A PLAN FOR RURAL TOURISM
WITH DOCUMENTATION OF HERITAGE IN ANJUNAD REGION OF KERALA

Preeti Harit Design

listing of heritage structures

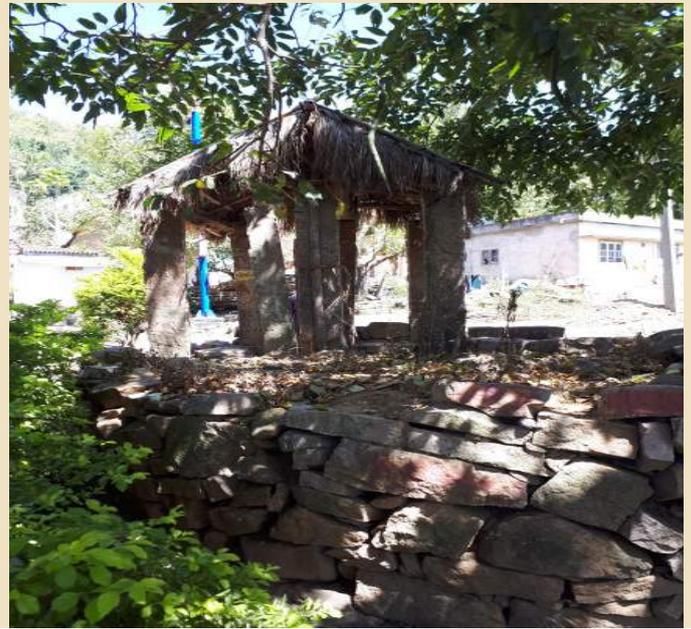
The site is in fine condition with some signs of deterioration. As there is garbage around, deterioration of stone has also happened with time.

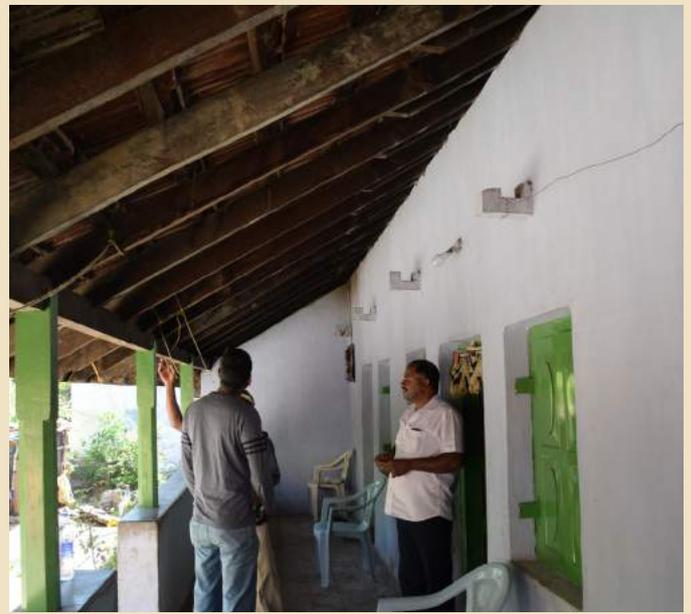
The structure is showing signs of deterioration with capillary rise in the walls. The internal roof with attic has saged. There is cement repair and the floor has been redone in cement.

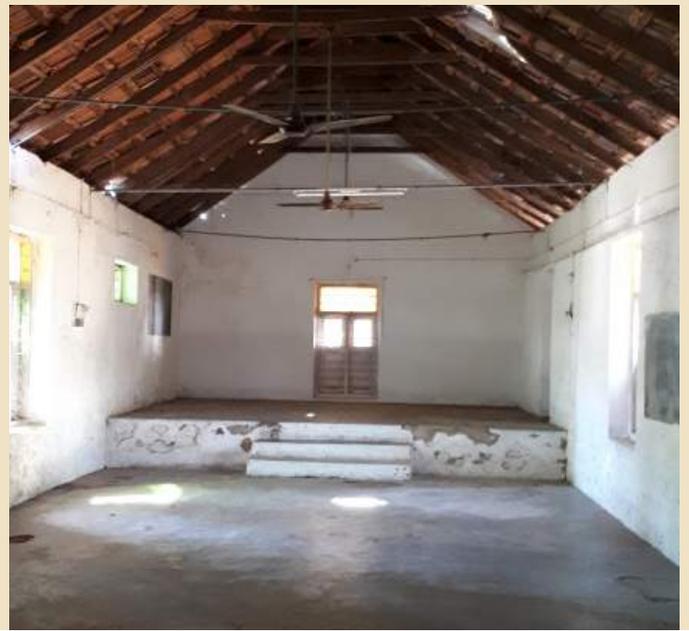
The structure has no use anymore therefore, getting neglected. It has started showing signs of deterioration with dampness on the floor and walls. Internally it has been changed with inappropriate use of new materials.

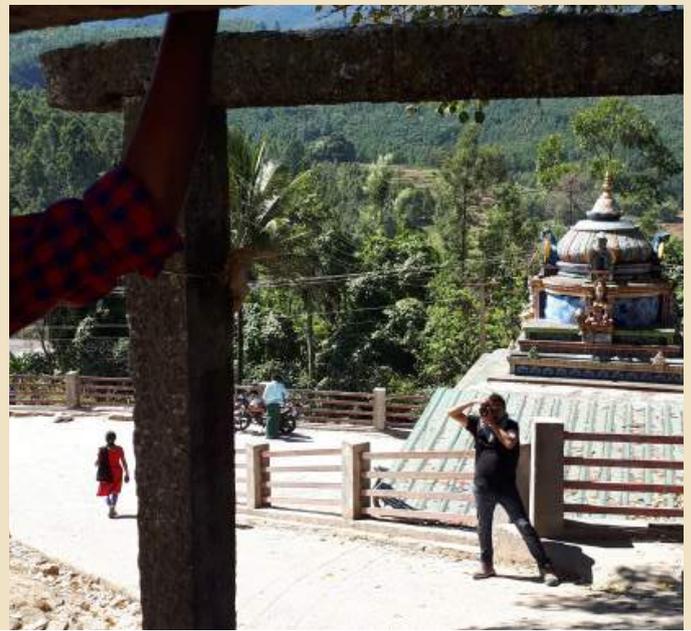
The gateway structure has started deteriorating with loose joints. The steps in front of the gateway are also in a deteriorating state due to negligence. A new road has been added that goes through the entire set up leaving the temple and tree on one side and gateway on the other. The temple has been repaired and added with top decorations, making it look entirely new.
