A PLAN FOR **RURAL TOURISM**
WITH DOCUMENTATION OF HERITAGE IN **ANJUNAD REGION OF KERALA**

Preeti Harit Design

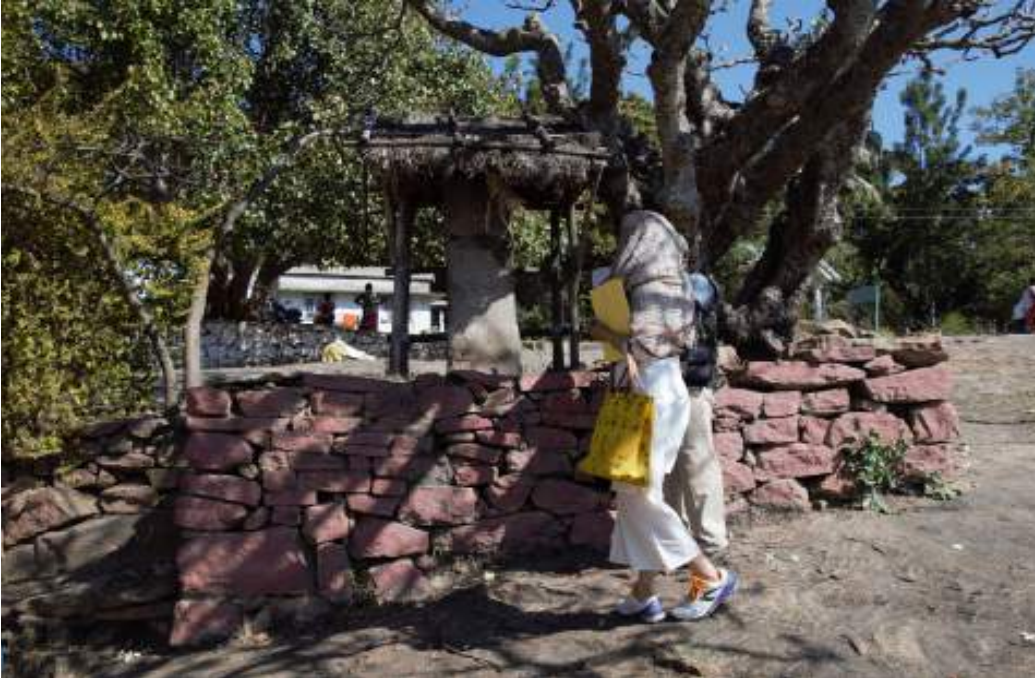
The site is in fine condition with some signs of deterioration. As there is garbage around, deterioration of stone has also happened with time.

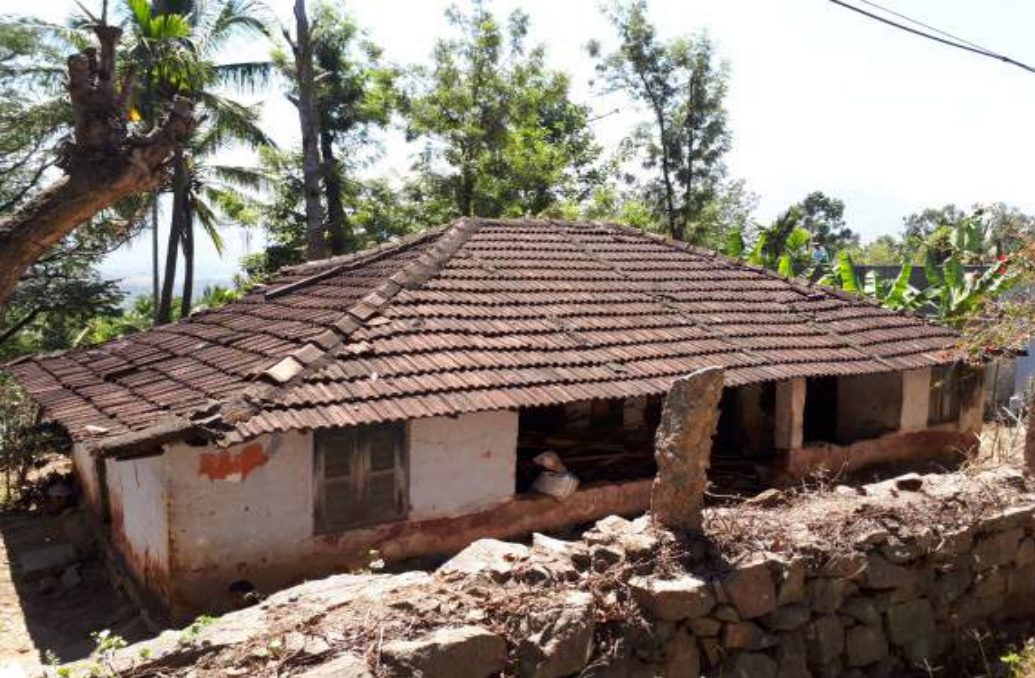
Since the structure is in mud, it is well maintained as it needs regular repair and maintenance. The final mud finishing is done every few weeks. At the back, the structure has been covered up with tin sheeting. There is soot deposition in the wood of the roof.

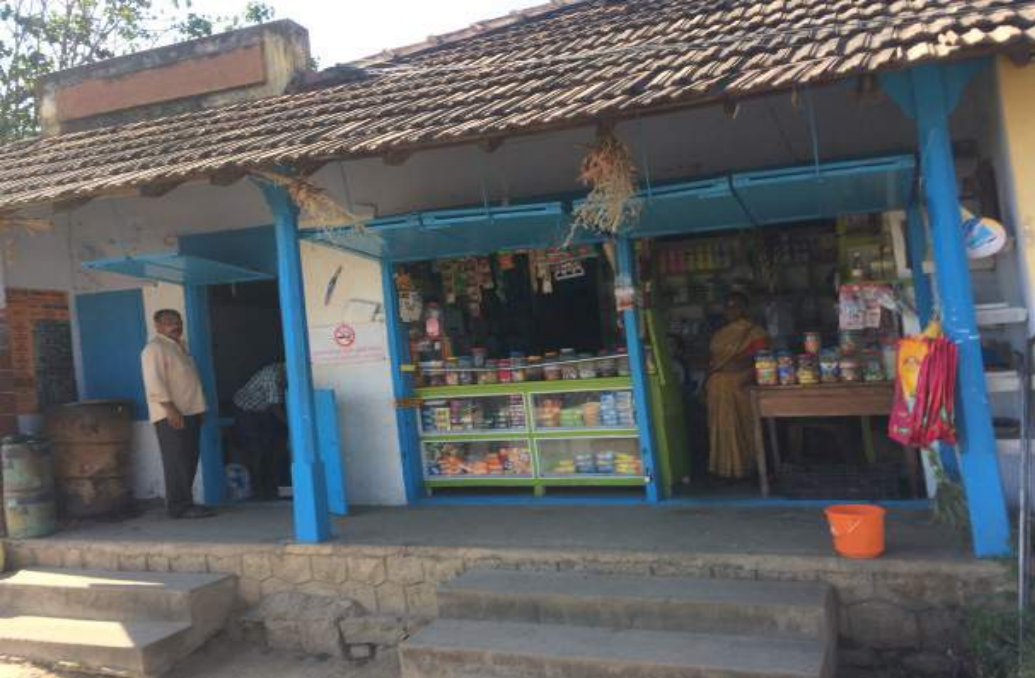
The structure has no use anymore therefore, getting neglected. It has started showing signs of deterioration with dampness on the floor and walls. Internally it has been changed with inappropriate use of new materials.
