A PLAN FOR RURAL TOURISM
WITH DOCUMENTATION OF HERITAGE IN ANJUNAD REGION OF KERALA

Preeti Harit Design

listing of heritage structures

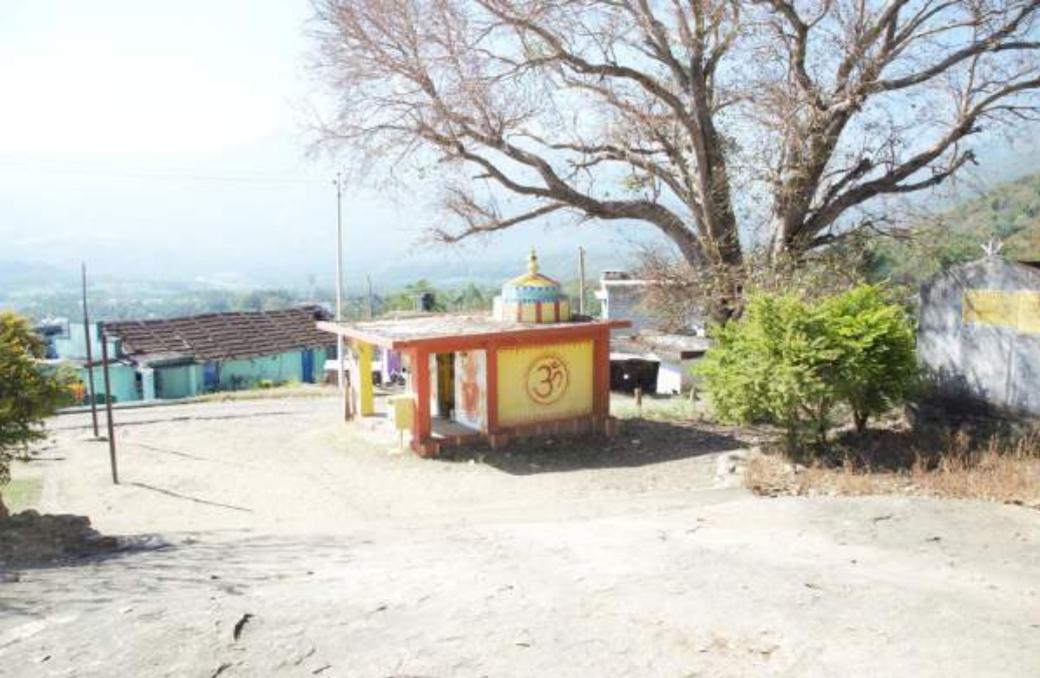
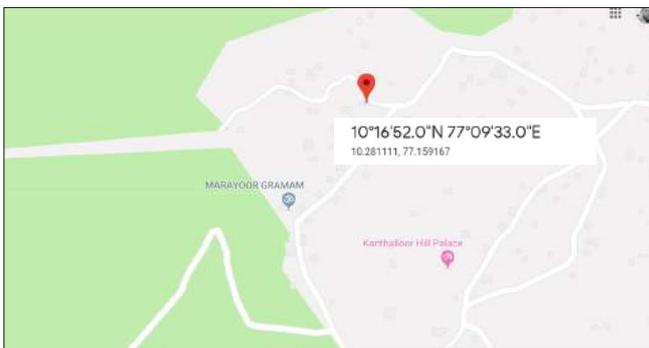
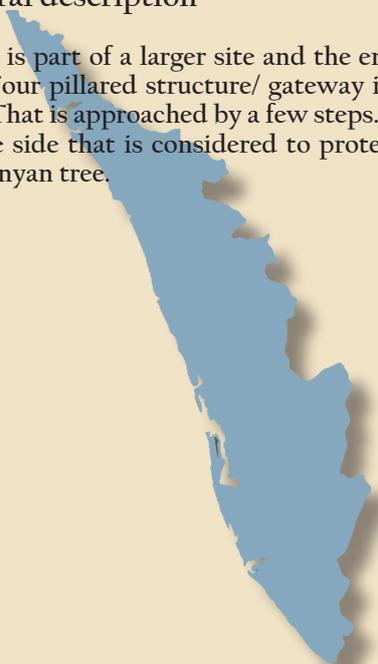
Serial No. - 1	
Name	
Present Name	Village entry
Past Name	Village entry
Any Other Name	
Age of Property	
Precise Date	
Approximate Date	200 - 300 years
Source of Information	Raj Durian
Grade	
Archaeological	I II III
Architectural	I II III
Historical	I II III
Final Grading	I

The site is in fine condition with some signs of deterioration. As there is garbage around, deterioration of stone has also happened with time.

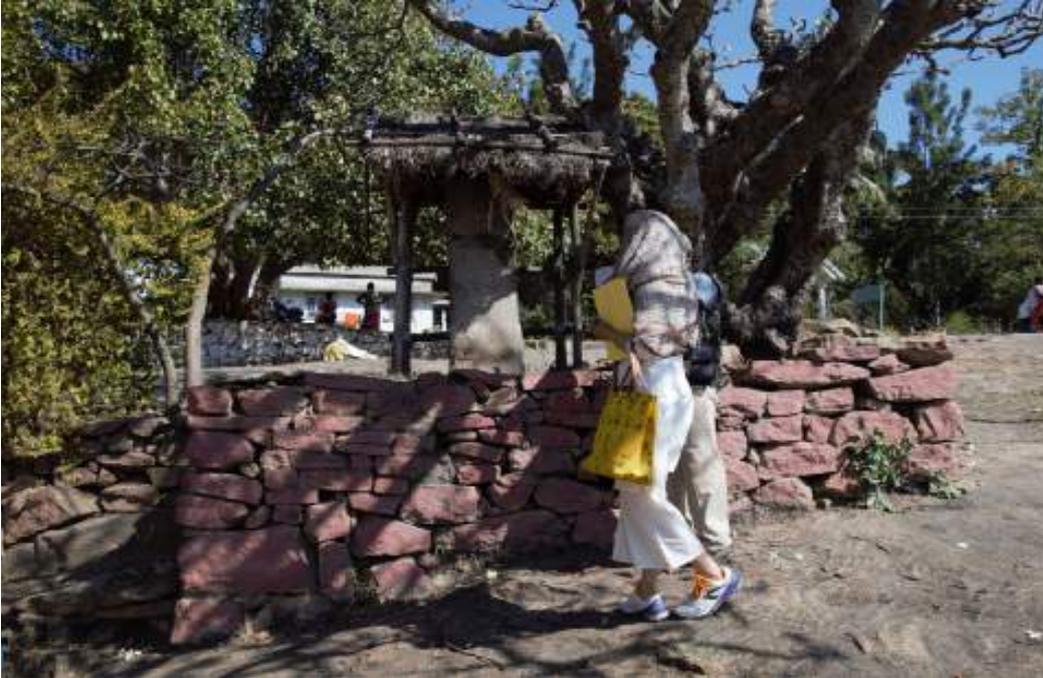
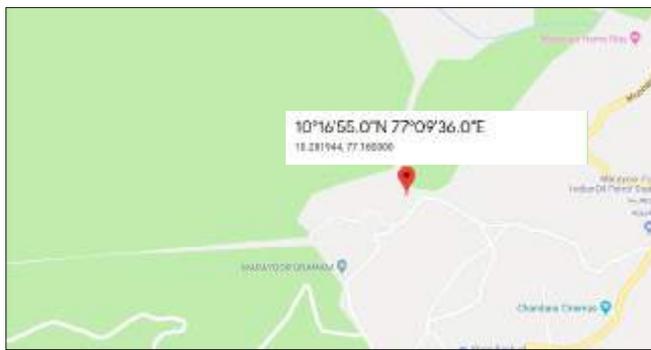
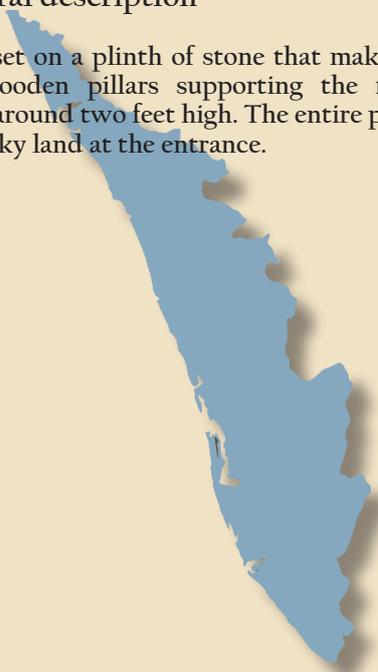
Serial No. - 2	
Name	
Present Name	Hero's stone
Past Name	Hero's stone
Any Other Name	
Age of Property	
Precise Date	
Approximate Date	200 - 300 years
Source of Information	Raj Durian
Grade	
Archaeological	I II III
Architectural	I II III
Historical	I II III
Final Grading	I

The stone is in a fine state. It is protected from sun and water by a small roof.

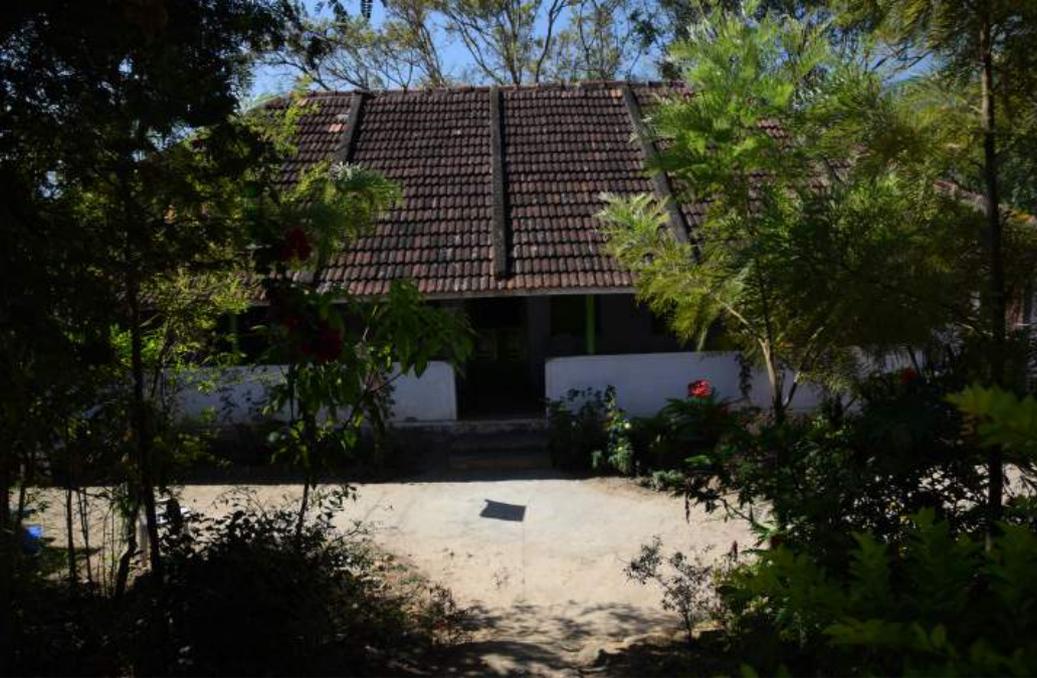
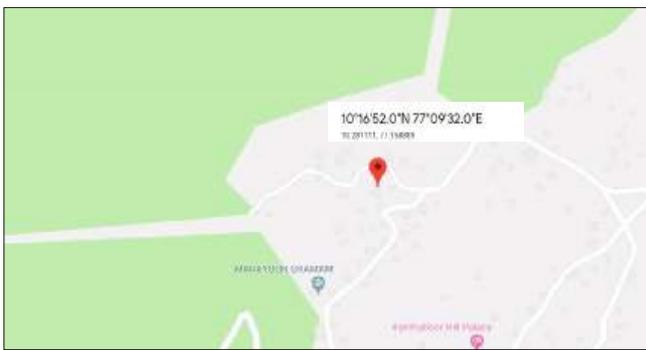
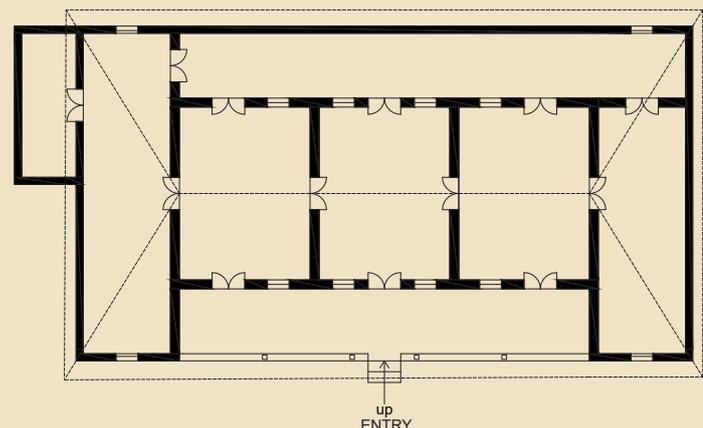
Serial No. - 3	
Name	
Present Name	Perivetttil
Past Name	Perivetttil
Any Other Name	
Age of Property	
Precise Date	
Approximate Date	75 years
Source of Information	Brinda P.S.
Grade	
Archaeological	I II III
Architectural	I II III
Historical	I II III
Final Grading	II A

The structure is showing signs of deterioration with capillary rise in the walls. The internal roof with attic has saged. There is cement repair and the floor has been redone in cement.

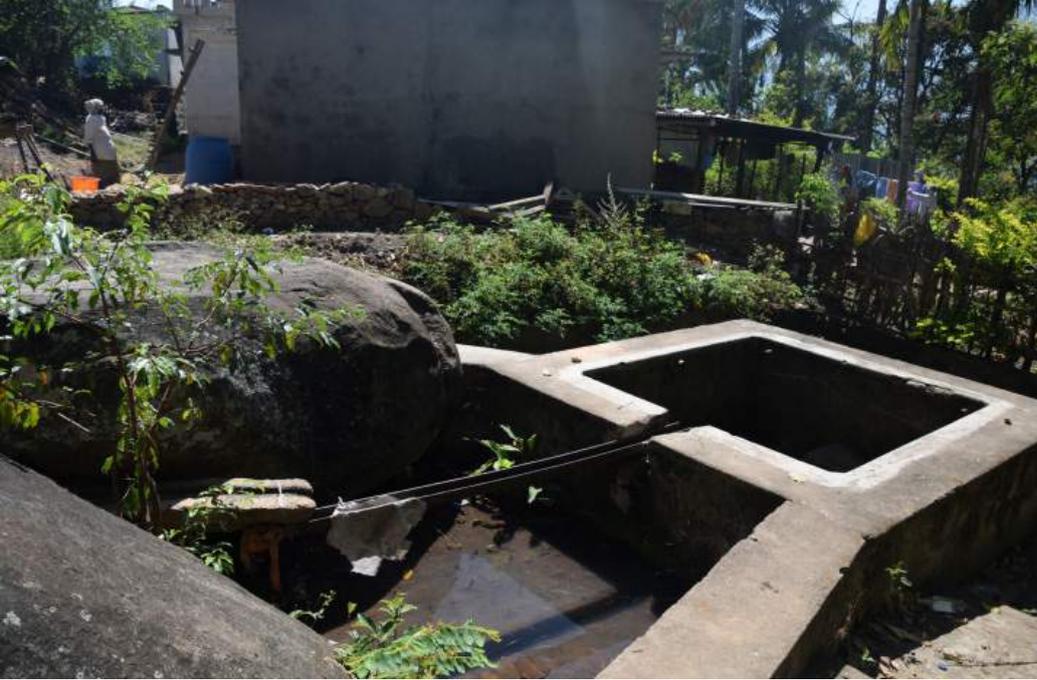
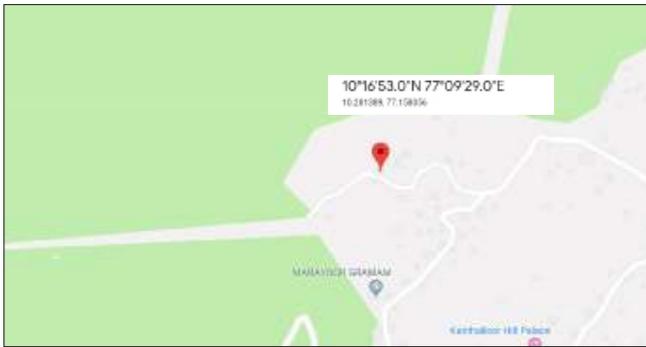
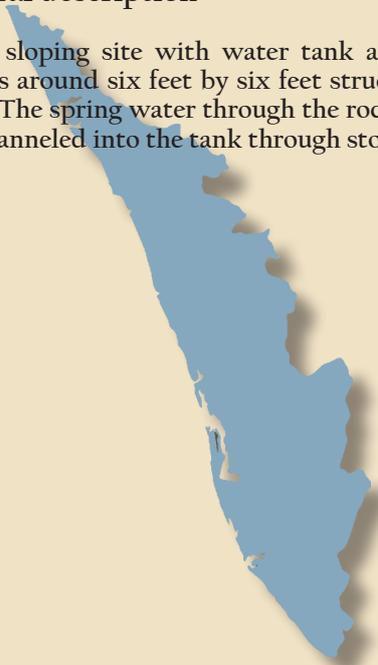
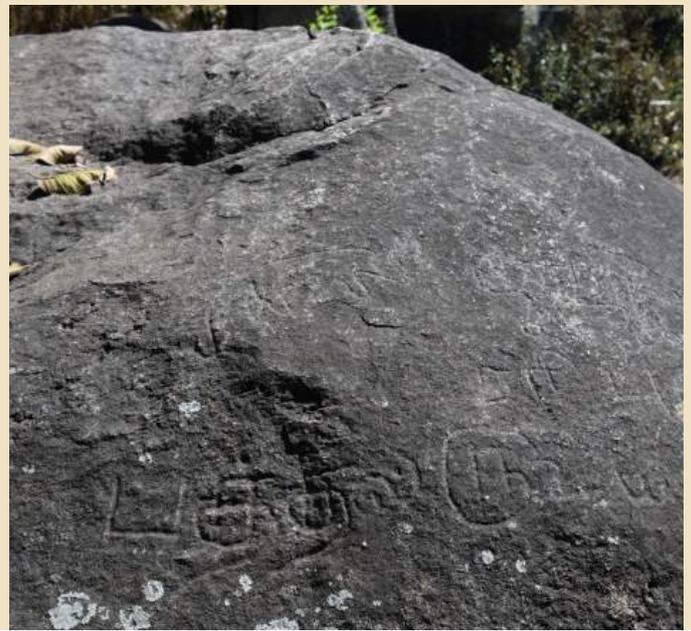
The structure is not in a good state with very little use. The surroundings are very dirty with plastic and garbage lying around.

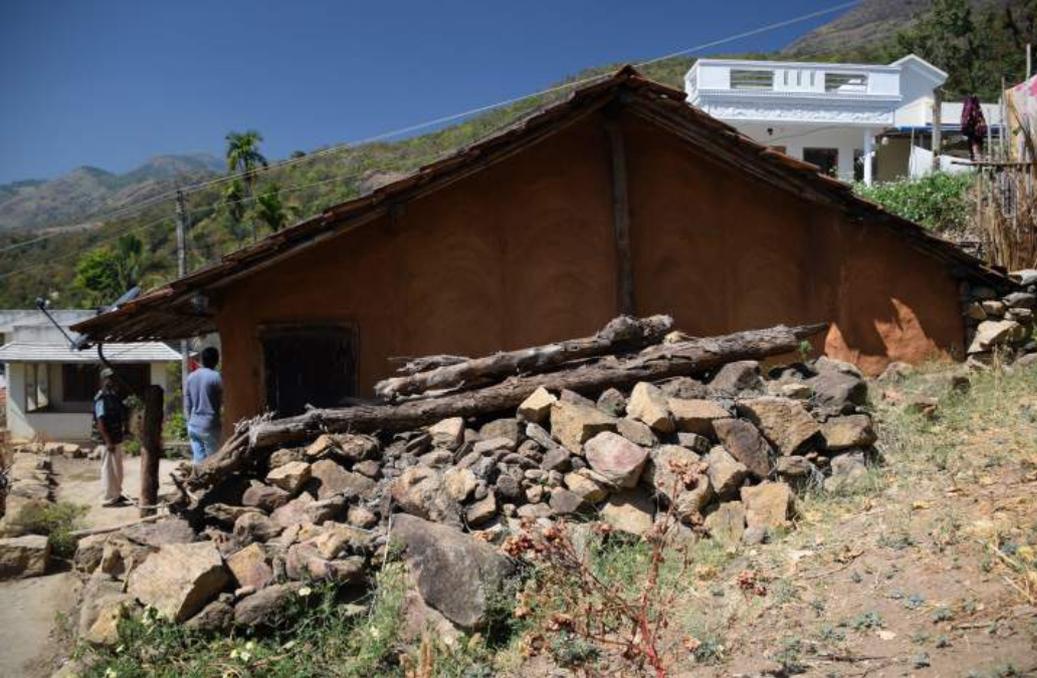
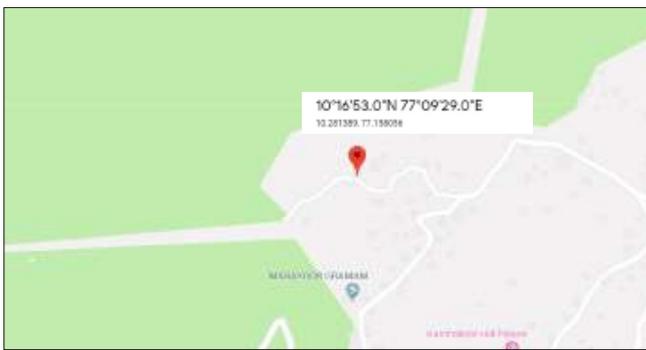
Serial No. - 5	
Name	
Present Name	Pankaj's House
Past Name	
Any Other Name	
Age of Property	
Precise Date	
Approximate Date	80 -- 90 years
Source of Information	
Grade	
Archaeological	I II III
Architectural	I II III
Historical	I II III
Final Grading	II B

Since the structure is in mud, it is well maintained as it needs regular repair and maintenance. The final mud finishing is done every few weeks. At the back, the structure has been covered up with tin sheeting. There is soot deposition in the wood of the roof.

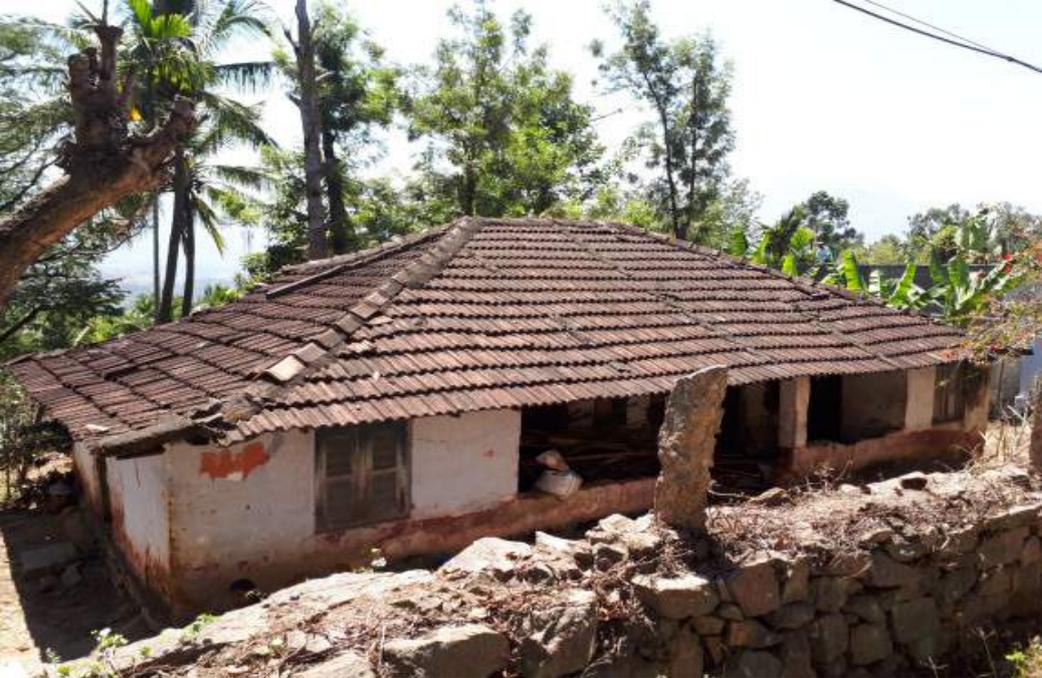
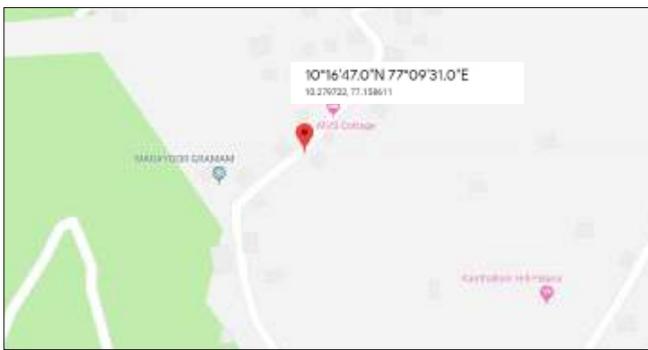
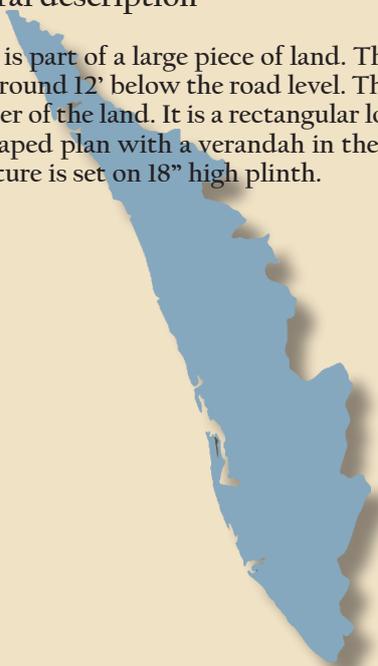
Serial No. - 6	
Name	
Present Name	Unknown
Past Name	Unknown
Any Other Name	
Age of Property	
Precise Date	
Approximate Date	100 years
Source of Information	
Grade	
Archaeological	I II III
Architectural	I II III
Historical	I II III
Final Grading	II

The structure is in a bad state because of negligence. The wood of the windows is getting deteriorated. The tiles on the roof have loosened. Plaster is cracking. The lime wash on the walls is peeling off. The structure is used for storage purpose that has further ruined the condition.

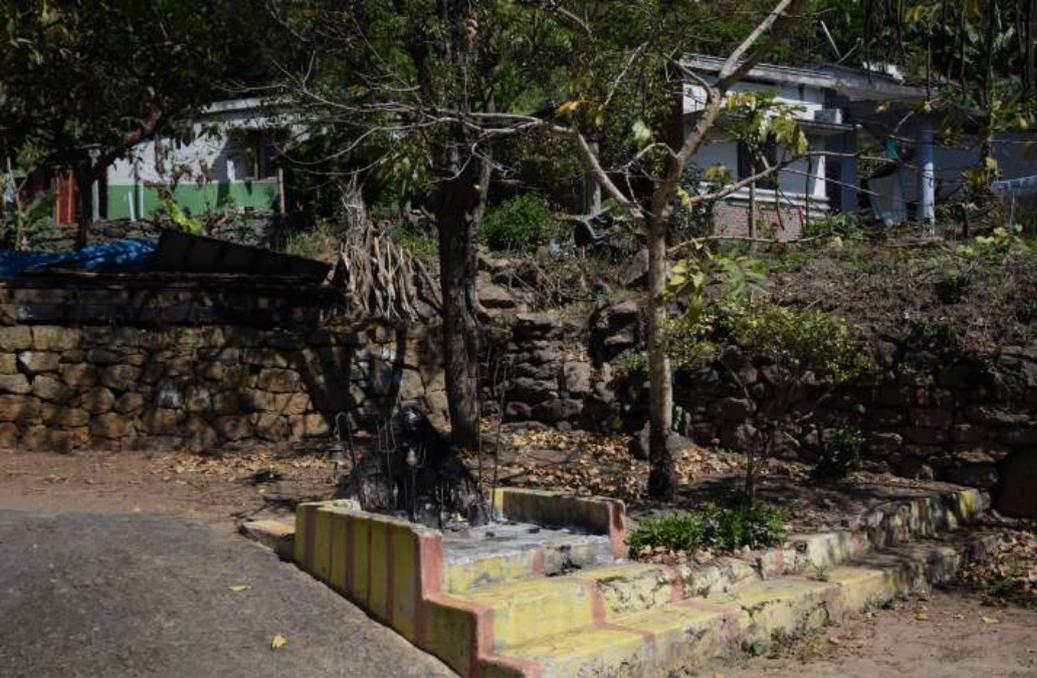
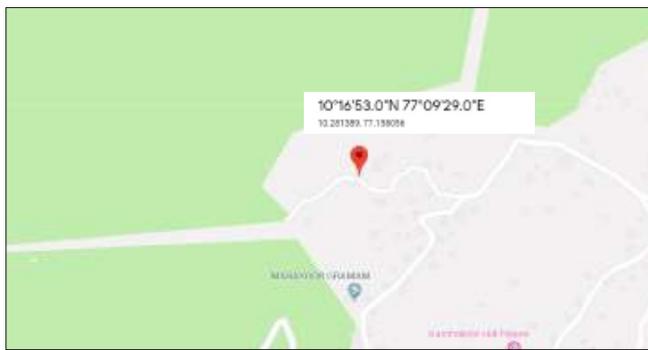
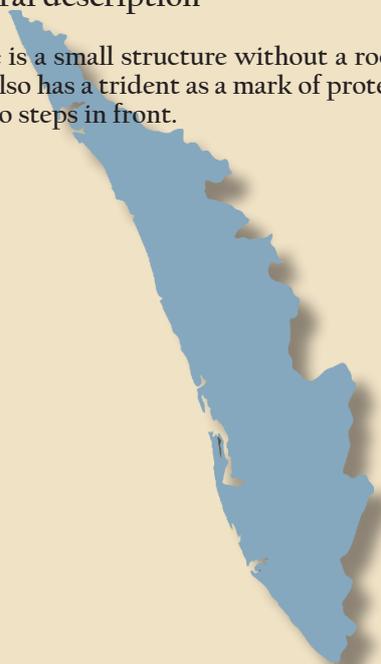
Serial No. - 7	
Name	
Present Name	Temple
Past Name	Not known
Any Other Name	
Age of Property	
Precise Date	
Approximate Date	200-300 years
Source of Information	Raj Durian
Grade	
Archaeological	I II III
Architectural	I II III
Historical	I II III
Final Grading	II A

The structure is in a well-maintained state. It has been lime-washed with red trimmings.

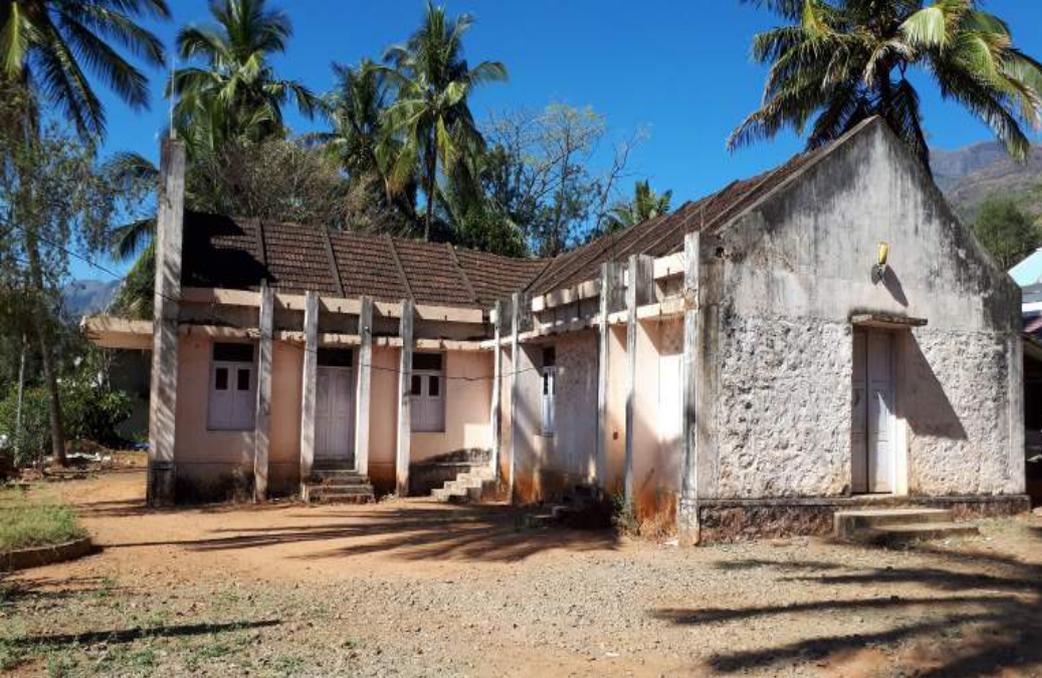
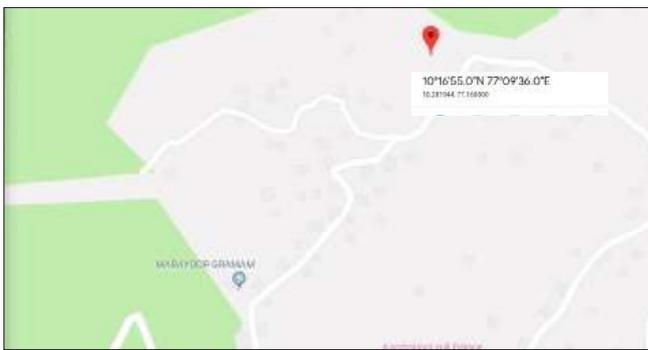
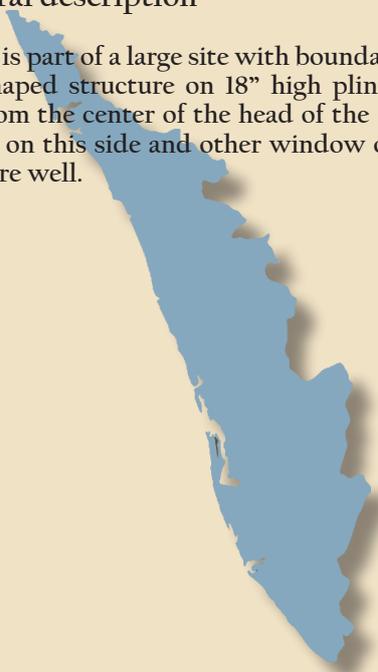
Serial No. - 8	
Name	
Present Name	St. Mary's Catholic Church
Past Name	St. Mary's Catholic Church
Any Other Name	
Age of Property	
Precise Date	1951
Approximate Date	
Source of Information	Priest Jose
Grade	
Archaeological	I II III
Architectural	I II III
Historical	I II III
Final Grading	II A

The structure has no use anymore therefore, getting neglected. It has started showing signs of deterioration with dampness on the floor and walls. Internally it has been changed with inappropriate use of new materials.

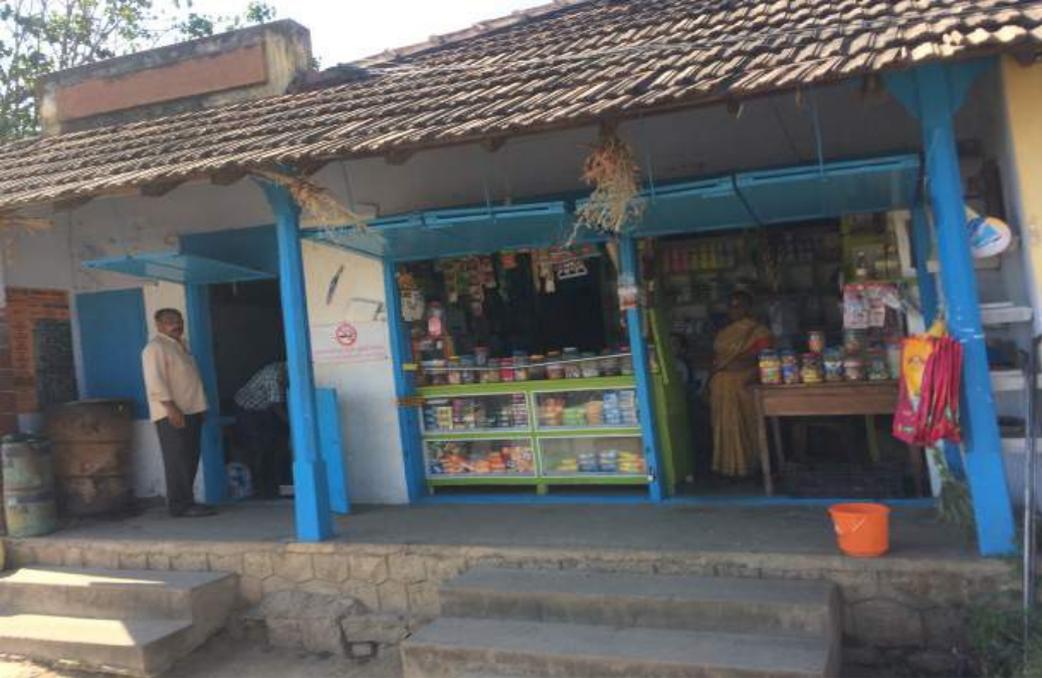
Serial No. - 9	
Name	
Present Name	Gauri Shop
Past Name	Gauri Shop
Any Other Name	
Age of Property	
Precise Date	
Approximate Date	60-70 years
Source of Information	Lakshmi
Grade	
Archaeological	I II III
Architectural	I II III
Historical	I II III
Final Grading	II B

The structure has started showing signs of deterioration. There is dampness in the walls. The floor has been changed with cemented floor and the front steps have been made new in bricks.

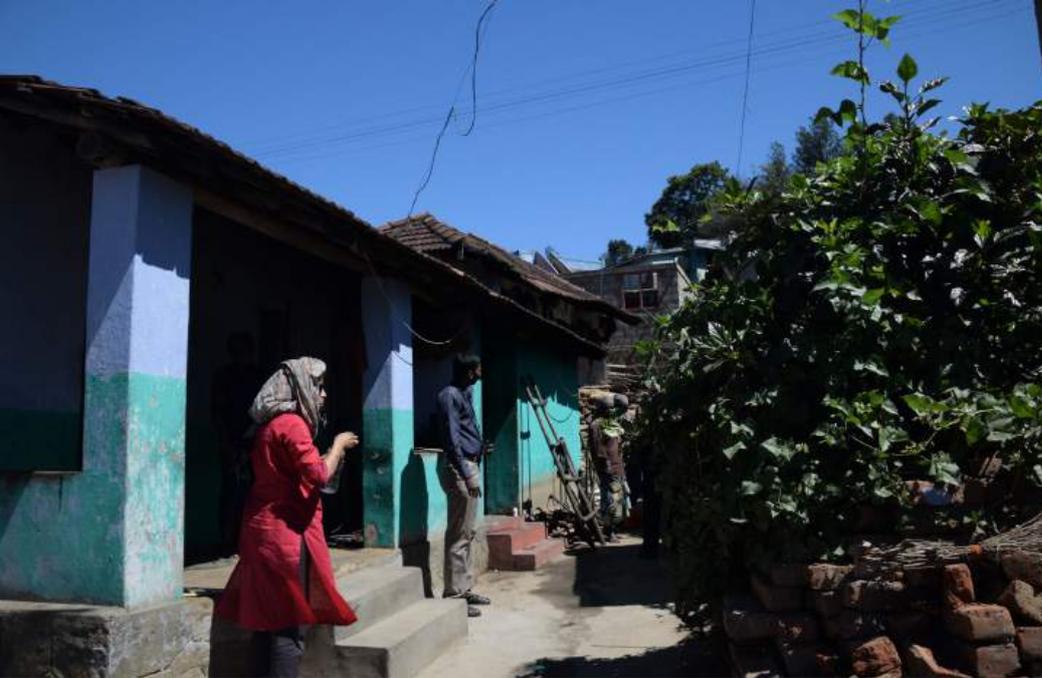
The structure is showing signs of deterioration with mud plaster cracking and falling off. The wooden and bamboo beams and rafters are rotting due to seepage and no maintenance. Terracotta tiles have moss deposition.

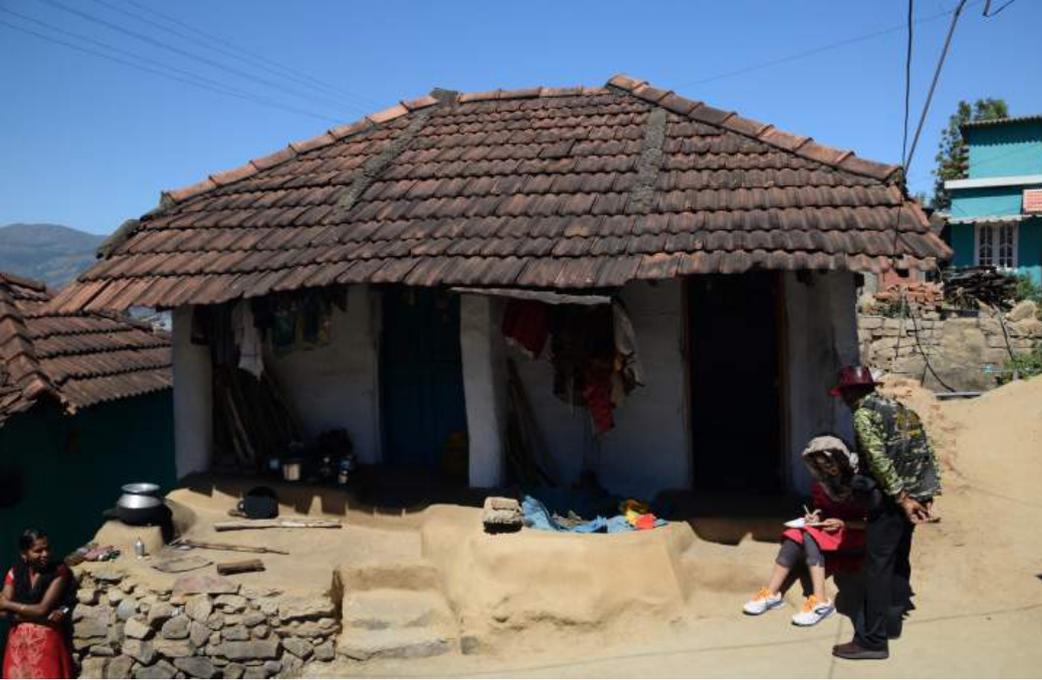
The structure has started showing signs of deterioration. It has been repaired in cement. Flooring has also been changed to the cement floor. Walls are regularly limewashed. The floor has been cemented and cemented steps have been added. There is a capillary rise visible in the plinth.

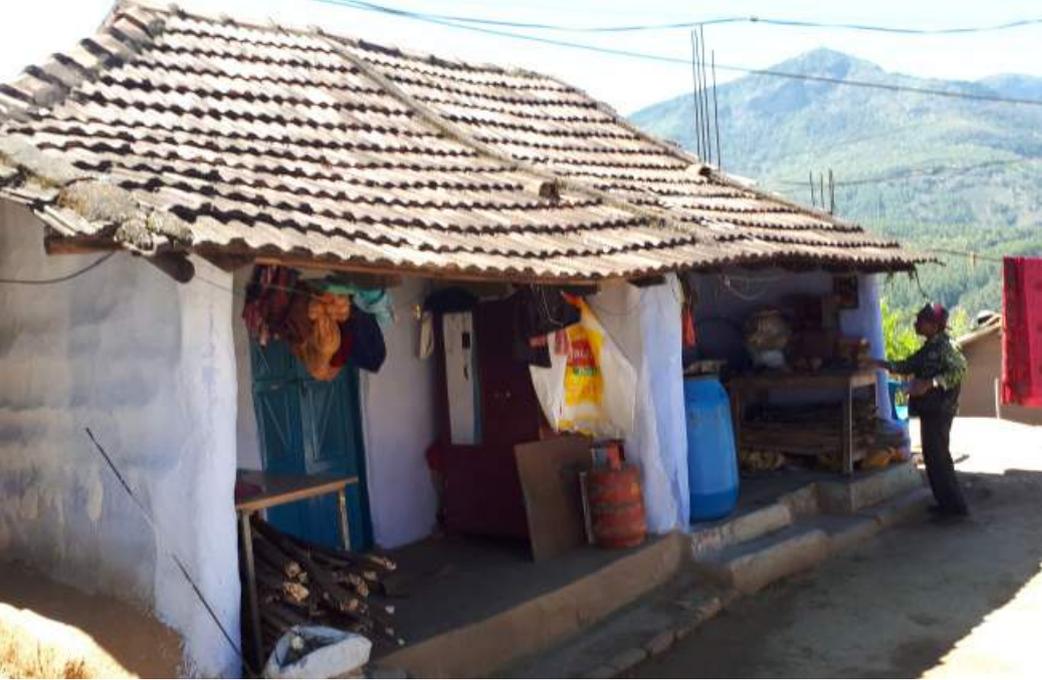
The mud walls and floor of the structure are well maintained as it is repaired on a regular basis. The entrance steps on one side are getting loosened. The roof is in deteriorating condition with soot deposition and moss deposition.

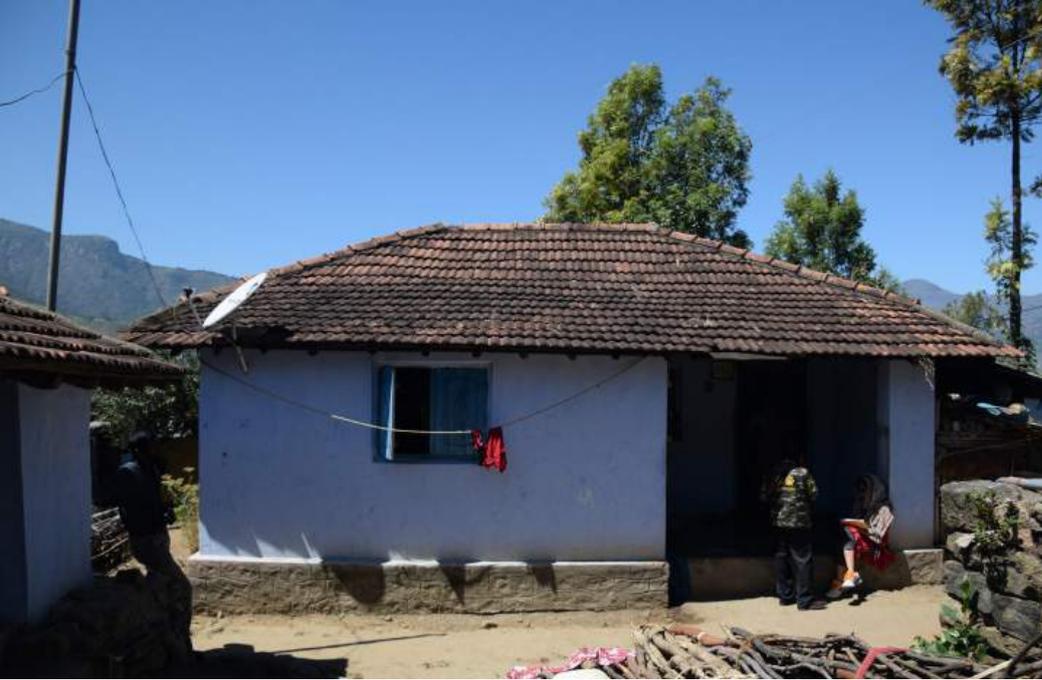
The mud walls of the structure are well maintained as it is repaired on a regular basis. There is soot deposition in the roof and moss deposition in tiles. The structure has been repaired with cement in a few places.

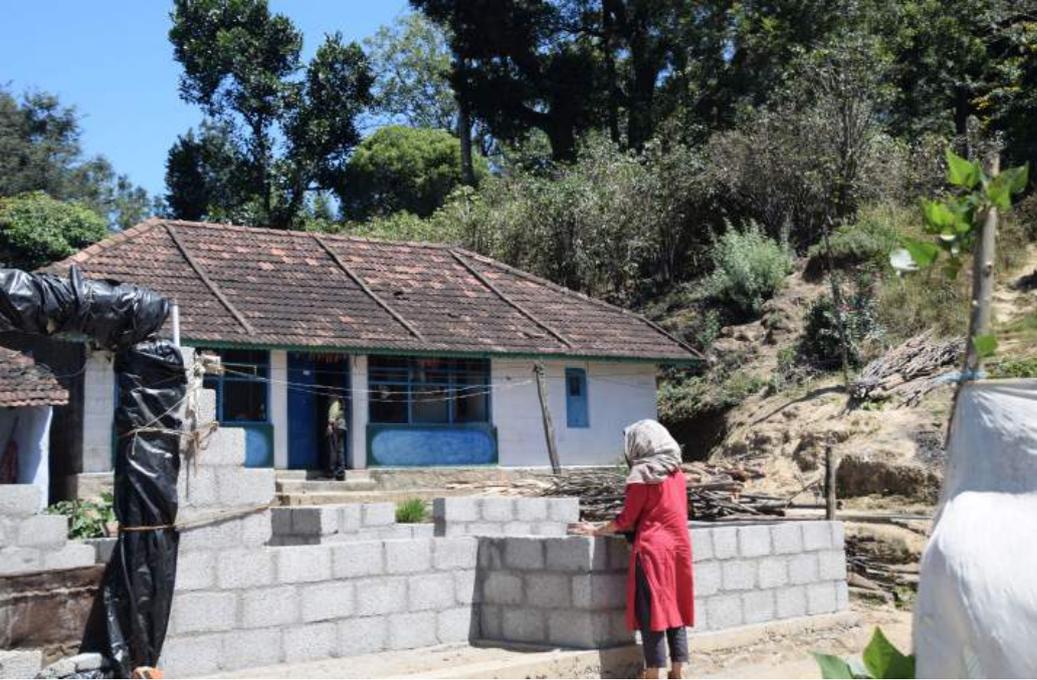
The structure has been repaired in cement. In most of the places, the floor has been changed to cemented floor. The walls are regularly whitewashed. The tiles and wood in the roof have soot deposition.

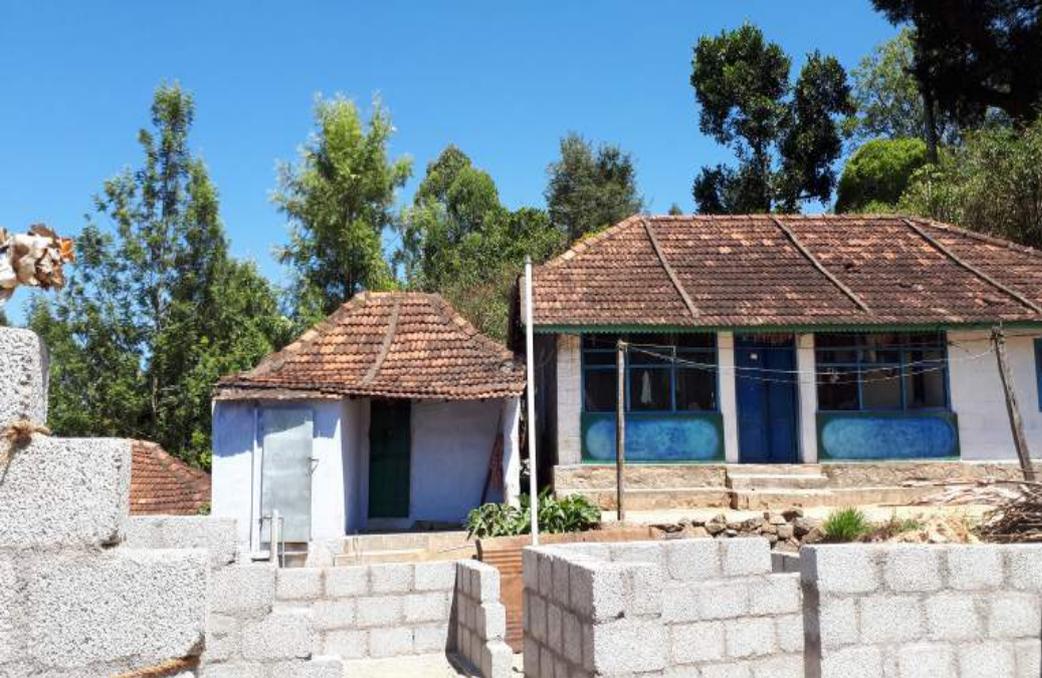
The structure is in good condition. There are some changes that have been made to the original structure like enclosing of the verandah.

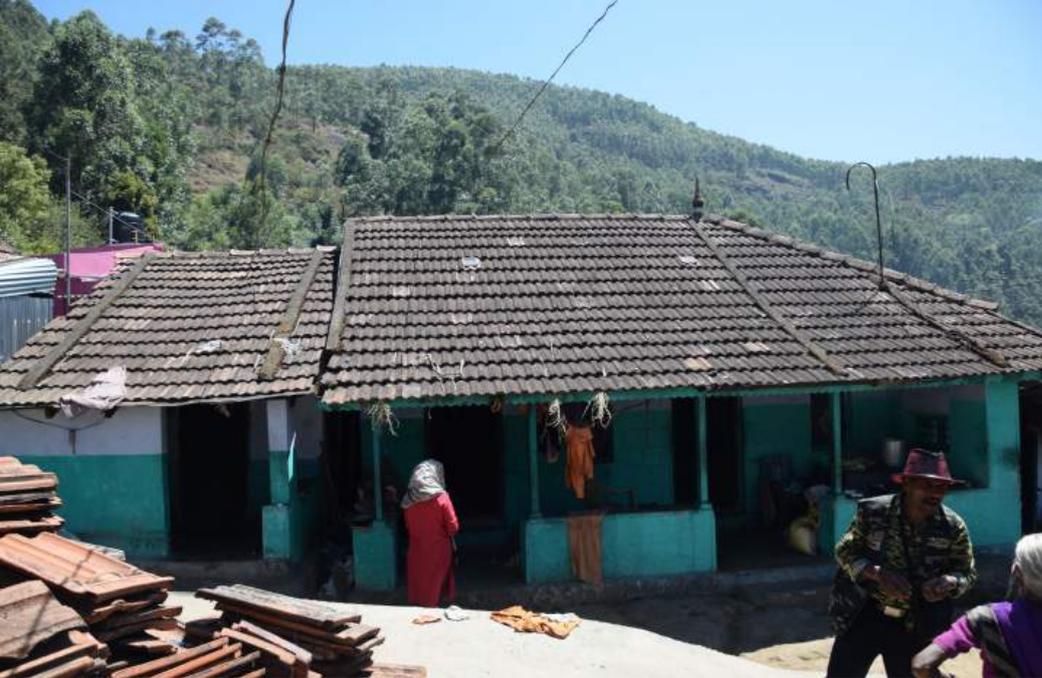
The structure is in a fine condition with few signs of deterioration. It has been whitewashed with lime. The wood in the roof is not maintained thereof has started rotting.

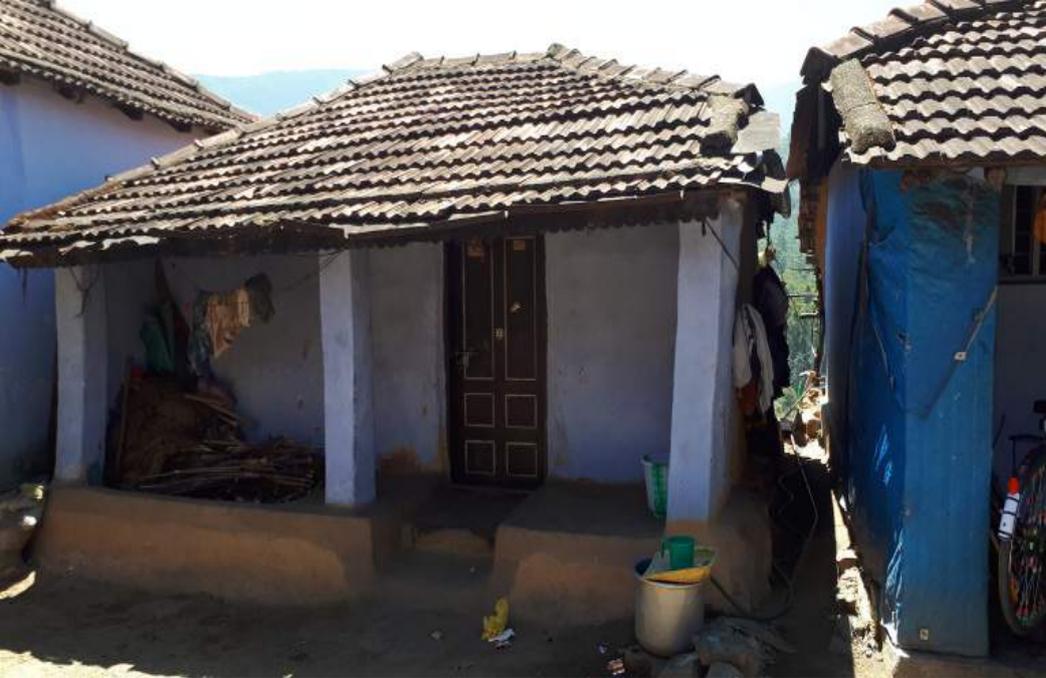
The structure is in fine condition. it has been lime washed regularly. There is a small extension at the back. The roof has soot deposition because of the kitchen. Because of soot and dampness from top the attic is in deteriorating state.

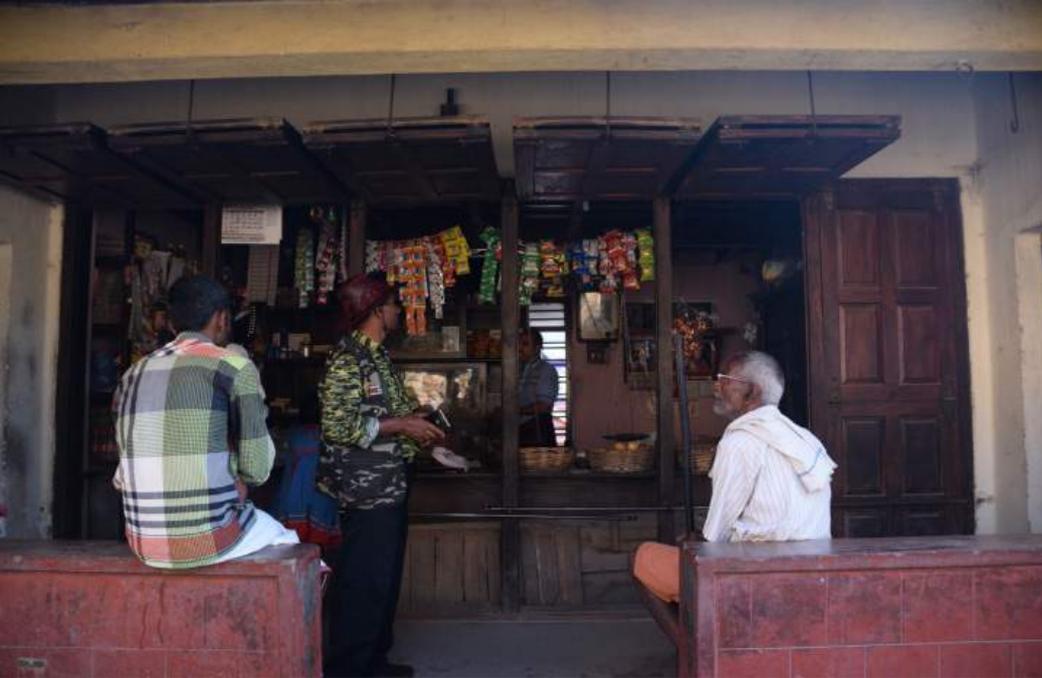
The structure is in well-maintained condition. It has been lime washed regularly. The roof has a broken drain pipe and soot deposition.

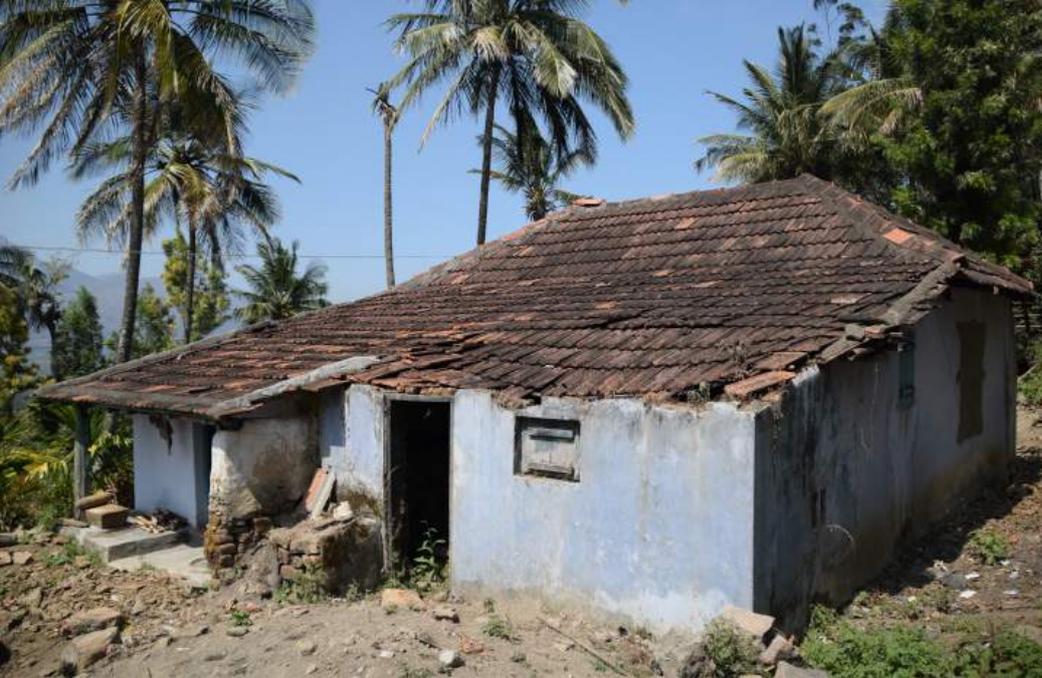
The front verandah of the structure has been modified and arches have been added. Another small room towards outside next to the verandah is also later addition. The white-wash from the structure is falling off. There is a capillary rise in the walls and wooden members in the roof are in deteriorating condition due to soot deposition and seepage.

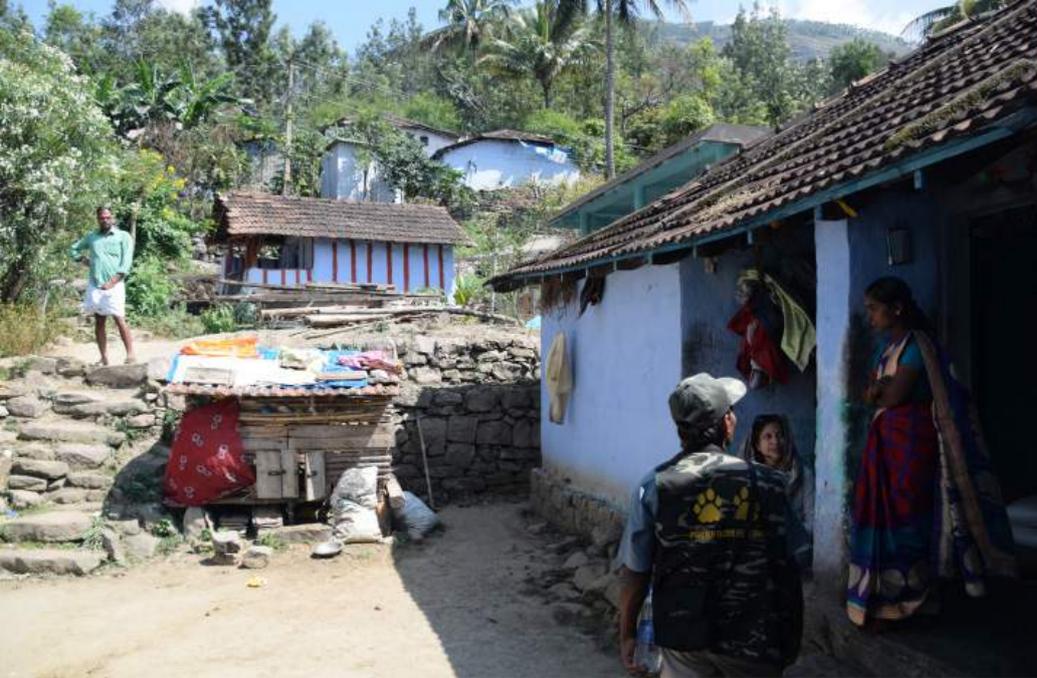
The structure is an abandoned structure with missing doors. There is seepage and capillary rise in the structure. Wooden windows are in deteriorating condition.

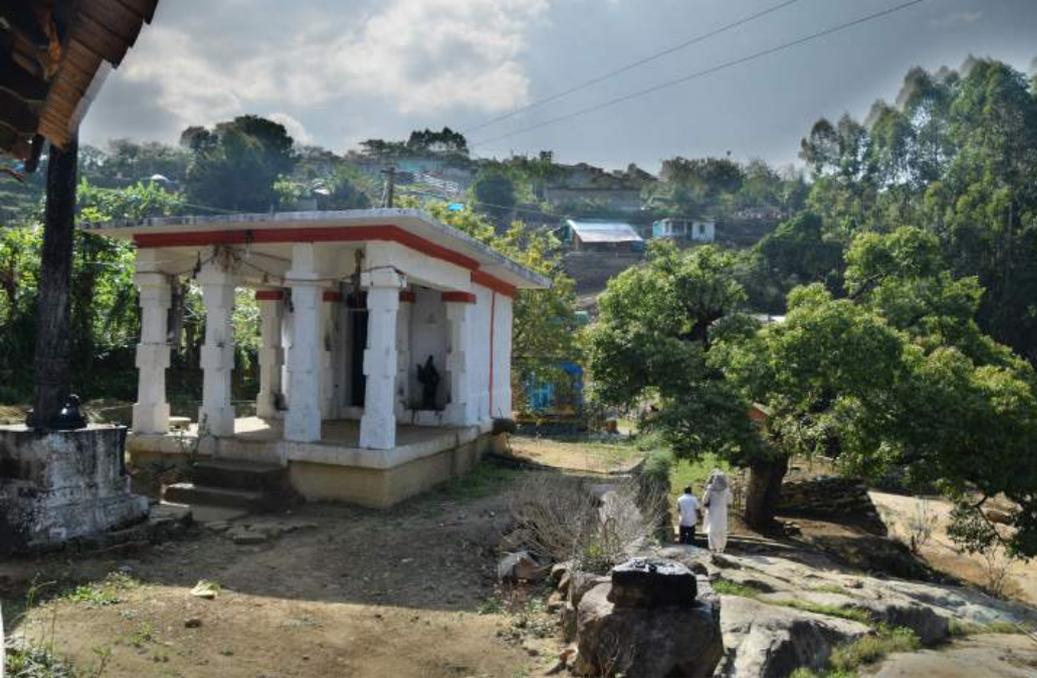
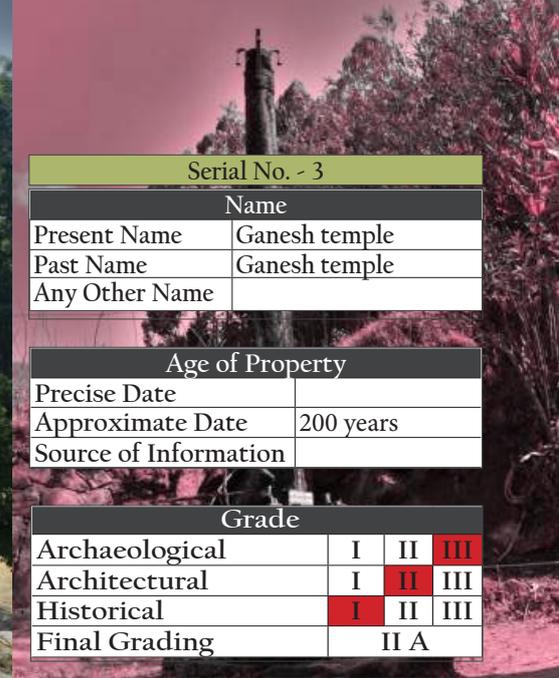
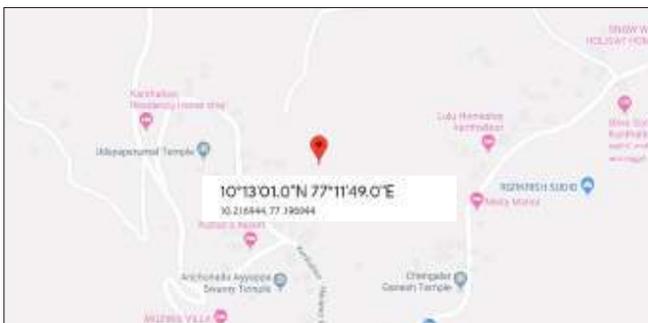
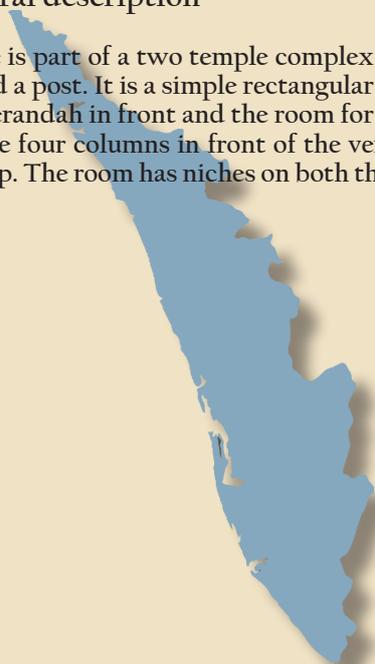
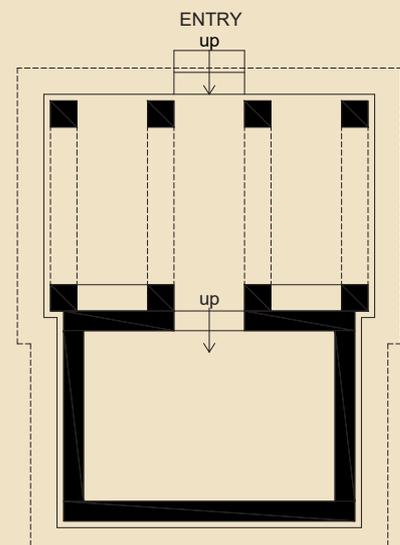
Serial No. - 3	
Name	
Present Name	Ganesh temple
Past Name	Ganesh temple
Any Other Name	
Age of Property	
Precise Date	
Approximate Date	200 years
Source of Information	
Grade	
Archaeological	I II III
Architectural	I II III
Historical	I II III
Final Grading	II A

There is soot deposition in some areas and deterioration due to water otherwise well-maintained structure. All whitewashed directly on stone.
