A PLAN FOR RURAL TOURISM
WITH DOCUMENTATION OF HERITAGE IN ANJUNAD REGION OF KERALA

Preeti Harit Design

listing of heritage structures

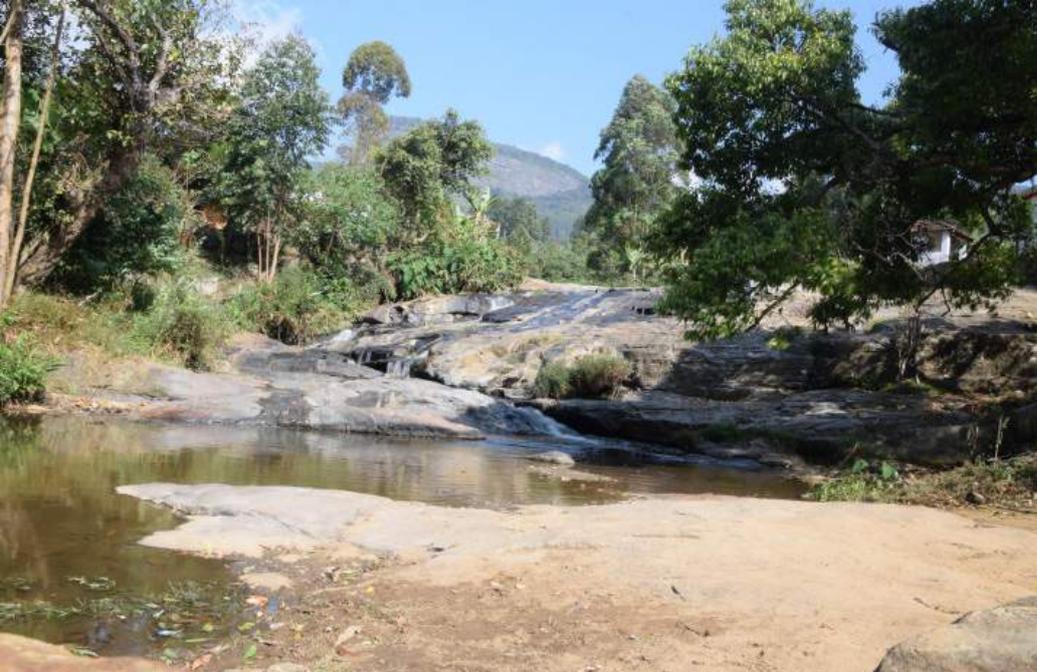
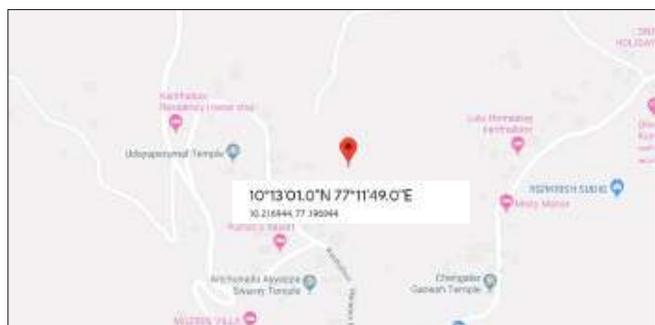
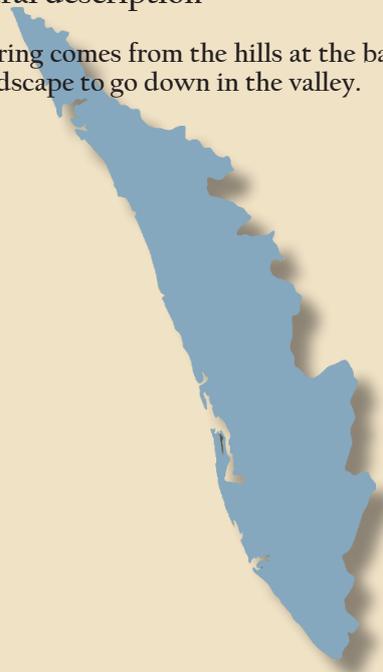
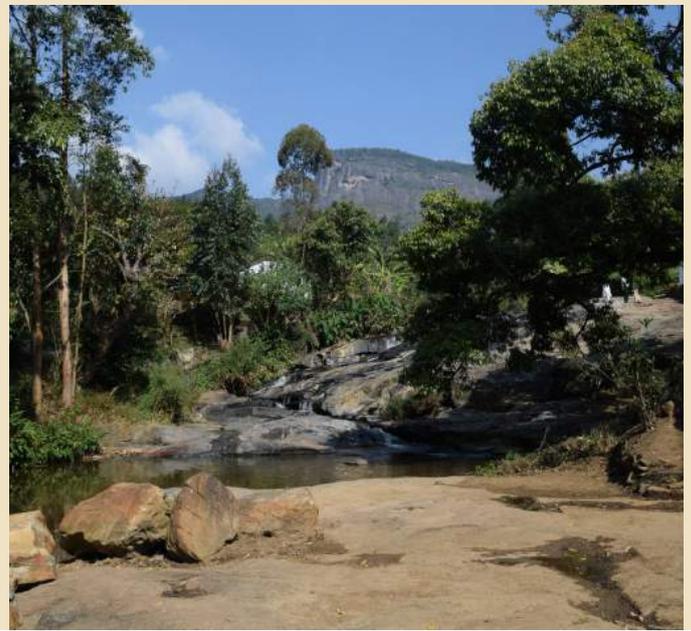
Serial No. - 4	
Name	
Present Name	Waterfall
Past Name	Waterfall
Any Other Name	
Age of Property	
Precise Date	
Approximate Date	500 years
Source of Information	
Grade	
Archaeological	I II III
Architectural	I II III
Historical	I II III
Final Grading	IA

There are plastic bags and filth around the edge of the waterbody as people bathe and wash clothes and leave the waste next to the waterbody.

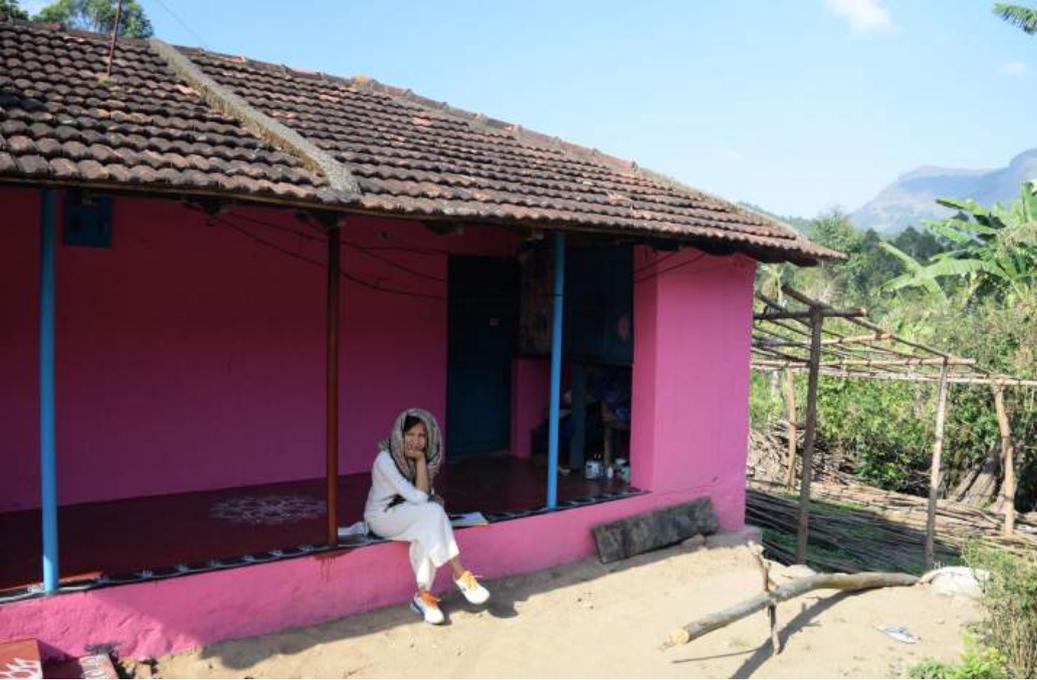
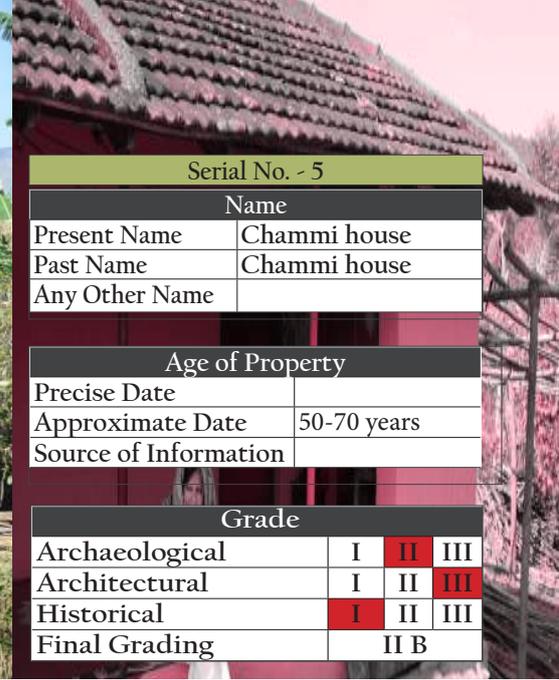
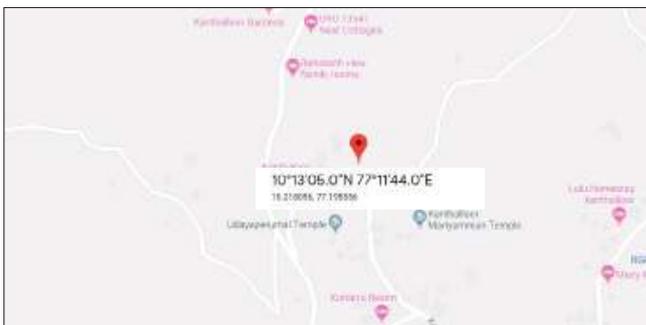
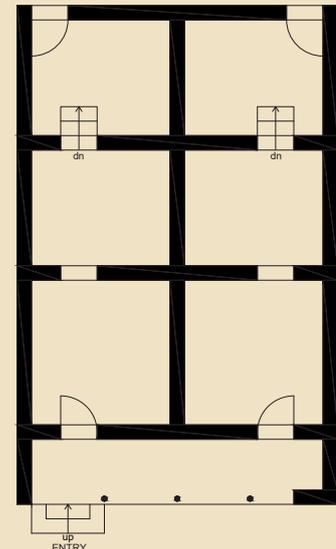
Serial No. - 5	
Name	
Present Name	Chammi house
Past Name	Chammi house
Any Other Name	
Age of Property	
Precise Date	
Approximate Date	50-70 years
Source of Information	
Grade	
Archaeological	I II III
Architectural	I II III
Historical	I II III
Final Grading	II B

The structure is in good condition as it looks recently repaired in cement. The floor has been cemented and painted.

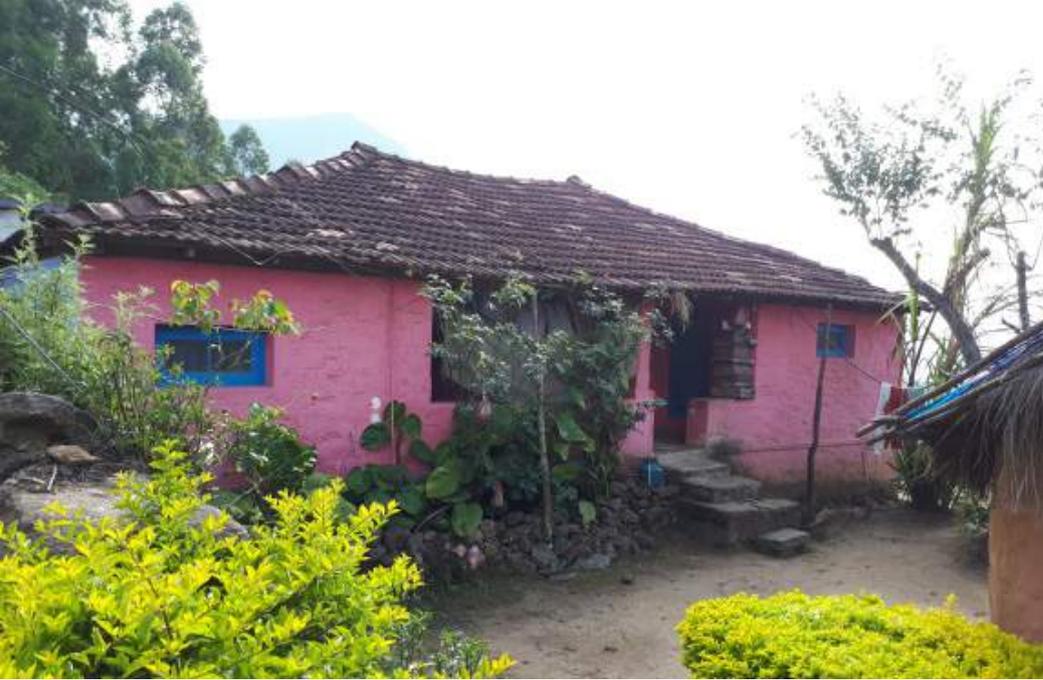
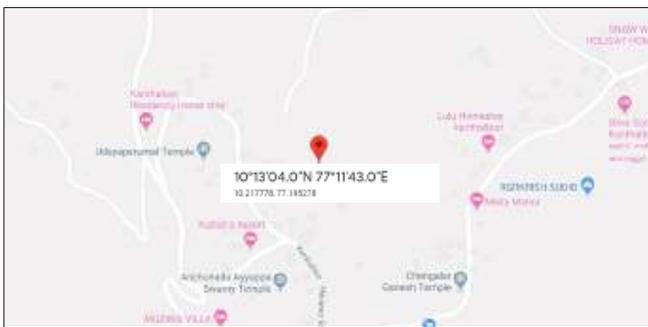
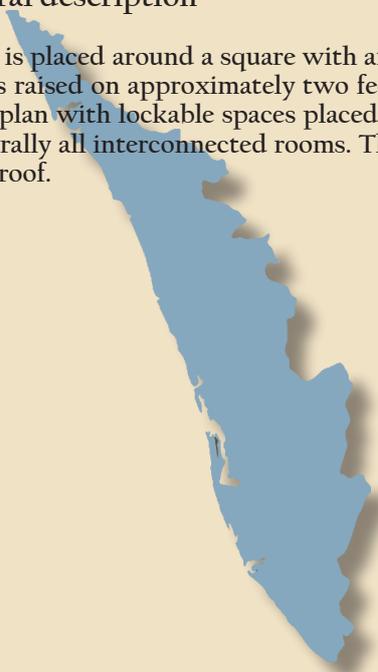
Serial No. - 6	
Name	
Present Name	Kanairrum
Past Name	Kanairrum
Any Other Name	
Age of Property	
Precise Date	
Approximate Date	50 years
Source of Information	
Grade	
Archaeological	I II III
Architectural	I II III
Historical	I II III
Final Grading	II B

The structure is generally in a good state with colored lime wash. It has been repaired in cement in a few places. There is capillary rise in the walls.

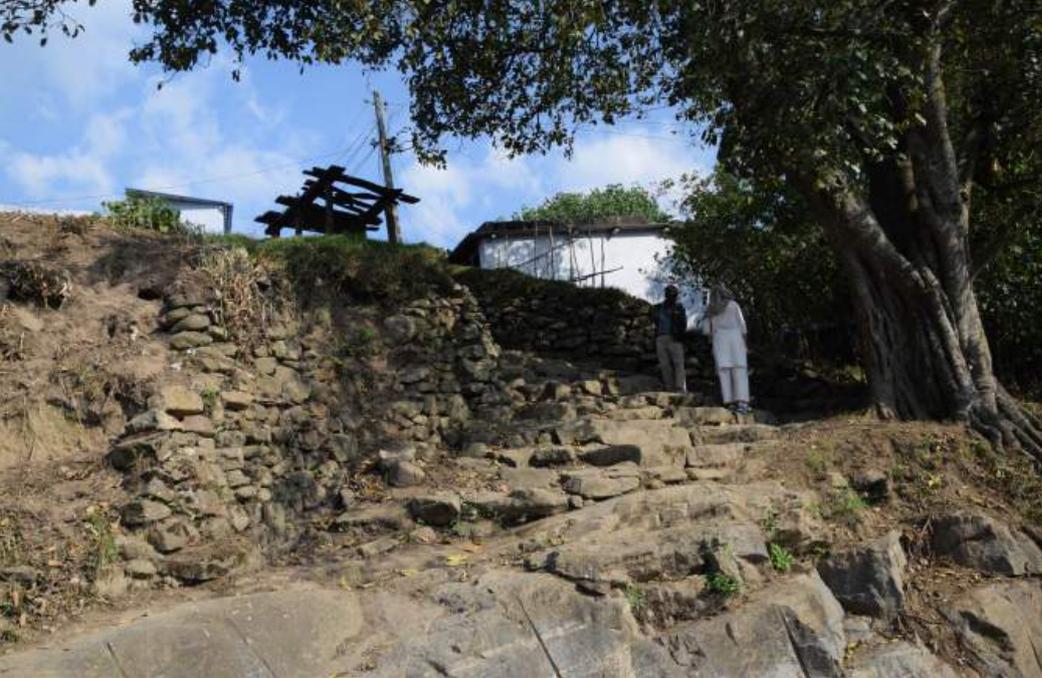
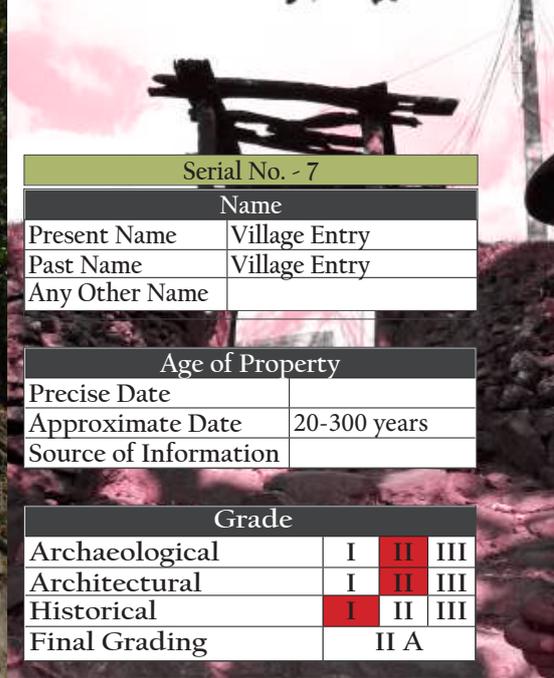
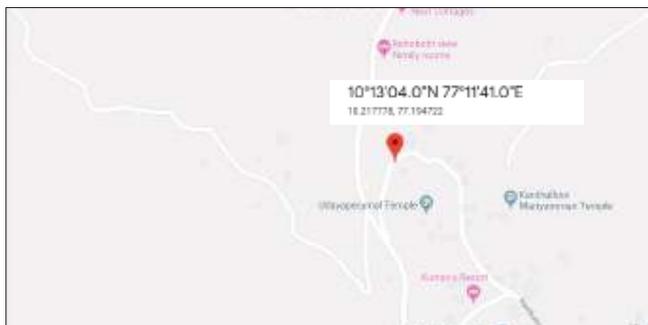
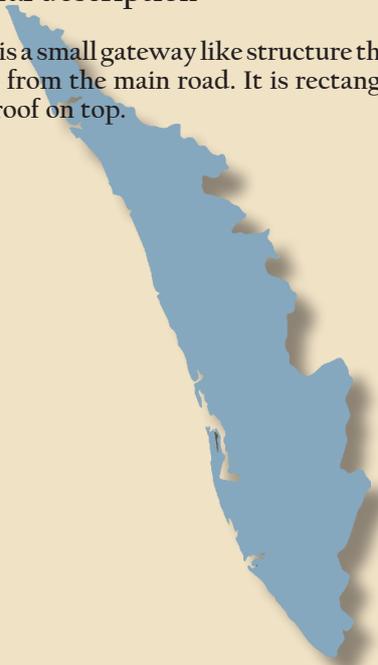
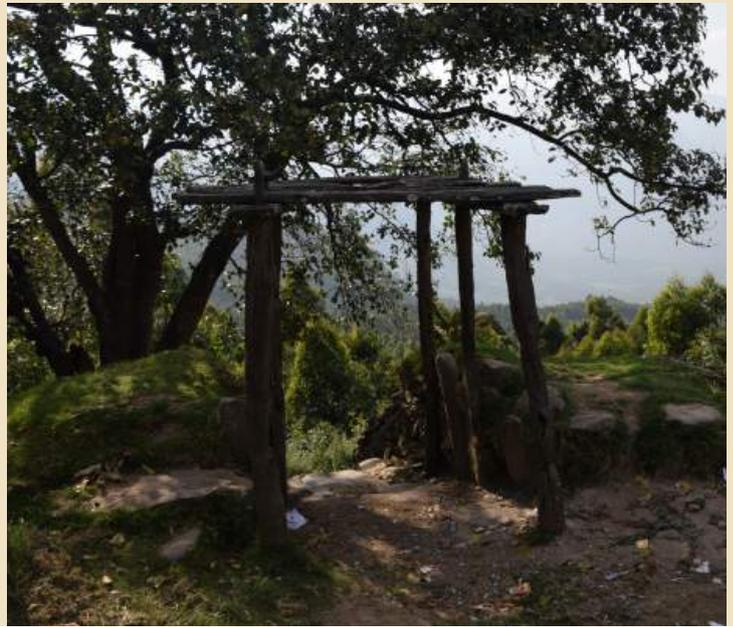
Serial No. - 7	
Name	
Present Name	Village Entry
Past Name	Village Entry
Any Other Name	
Age of Property	
Precise Date	
Approximate Date	20-300 years
Source of Information	
Grade	
Archaeological	I II III
Architectural	I II III
Historical	I II III
Final Grading	II A

The structure is in a bad state with rotting wooden columns and roof. The steps in front are broken and unkept. The entry has no use therefore, the site is neglected. One of the main features that is the temple at the entrance is not there anymore.

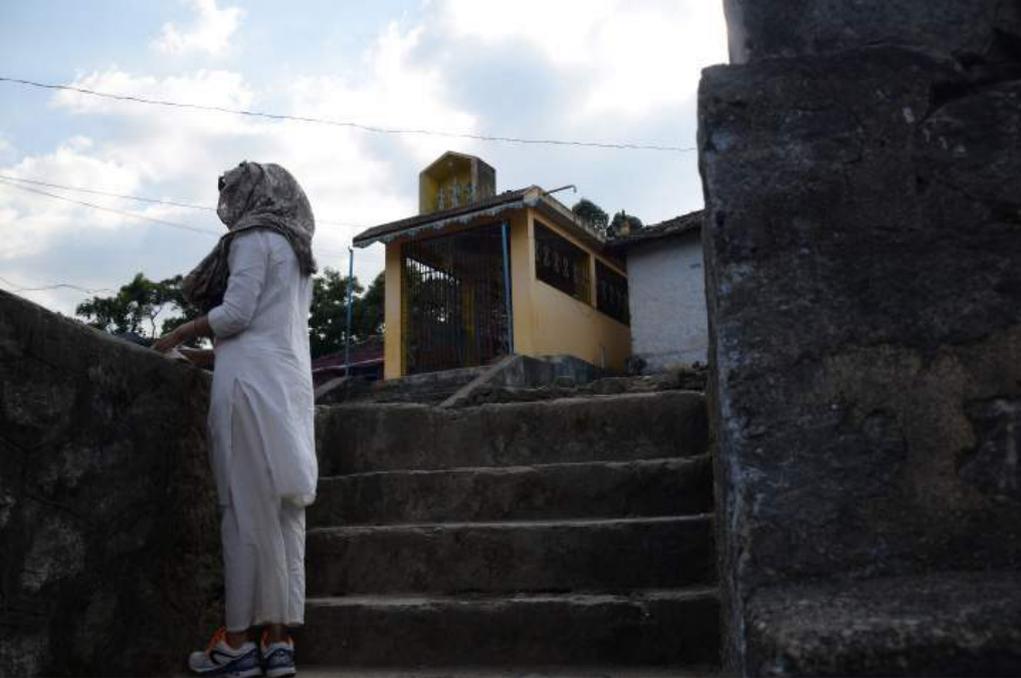
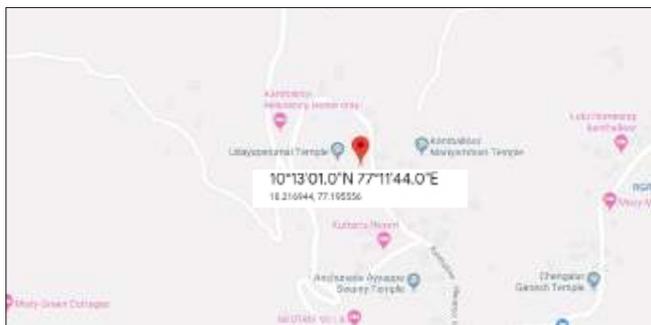
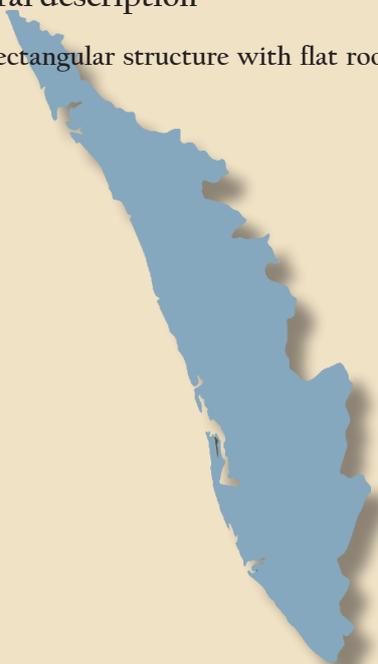
Serial No. - 8	
Name	
Present Name	Maha Vishnu Temple
Past Name	Maha Vishnu Temple
Any Other Name	
Age of Property	
Precise Date	
Approximate Date	50 years
Source of Information	
Grade	
Archaeological	I II III
Architectural	I II III
Historical	I II III
Final Grading	III

The structure has been well maintained with regular repair work. It has been repaired in cement with cemented steps and lime wash on walls. New metal gate and grills have been added in the openings.

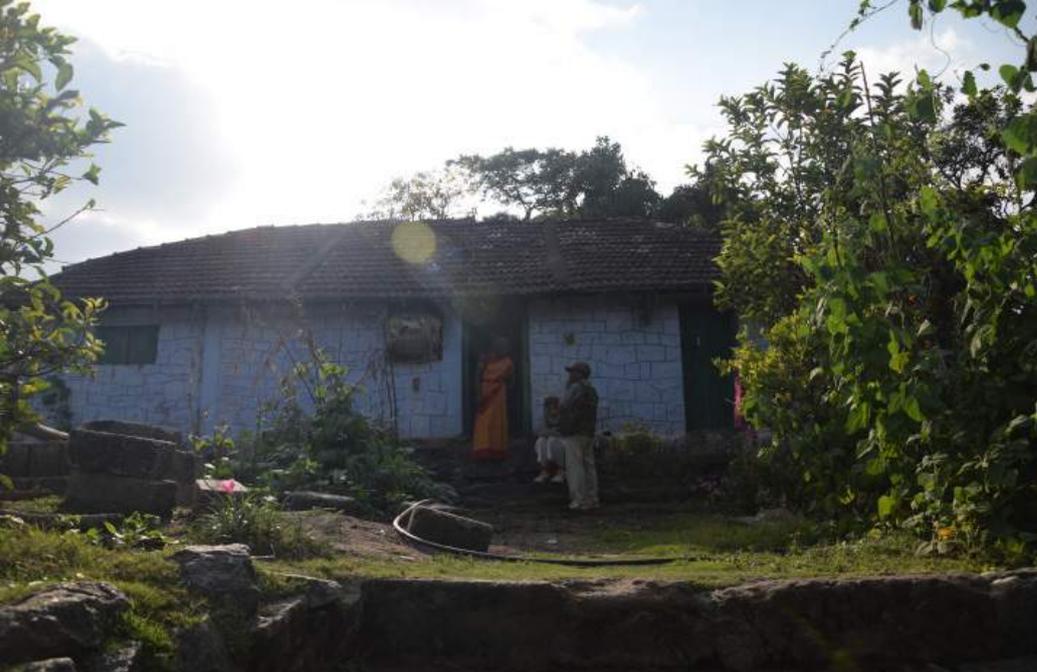
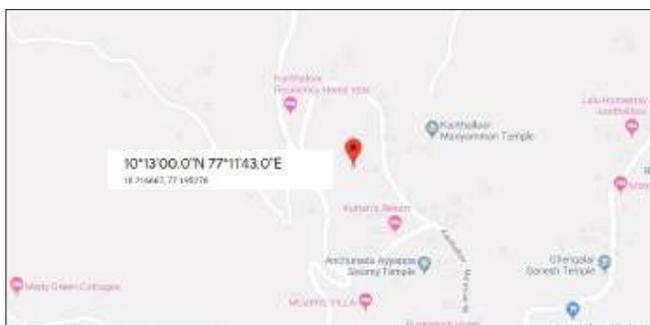
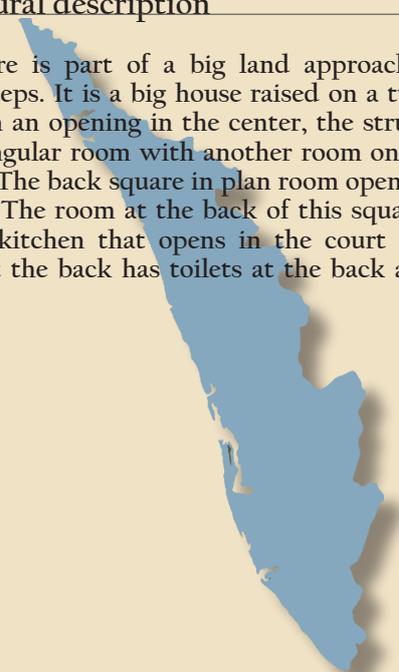
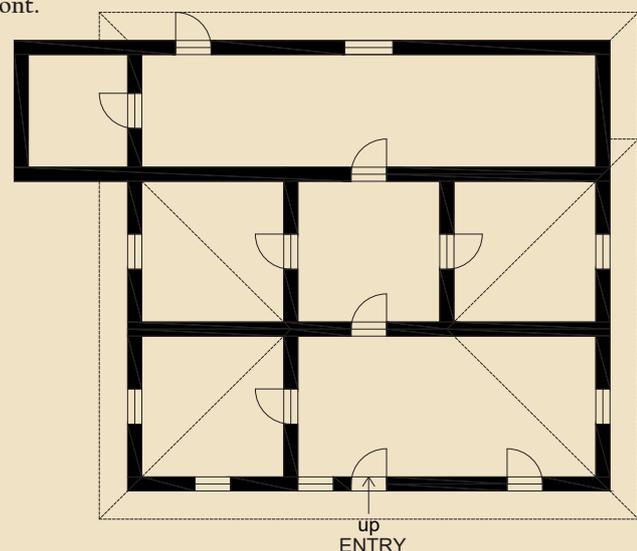
The structure though lime washed from outside is showing signs of deterioration with capillary rise in the walls. There is soot deposition in the roof and wooden members are getting deteriorated because of negligence.
