A PLAN FOR **RURAL TOURISM**
WITH DOCUMENTATION OF HERITAGE IN **ANJUNAD REGION OF KERALA**

Preeti Harit Design

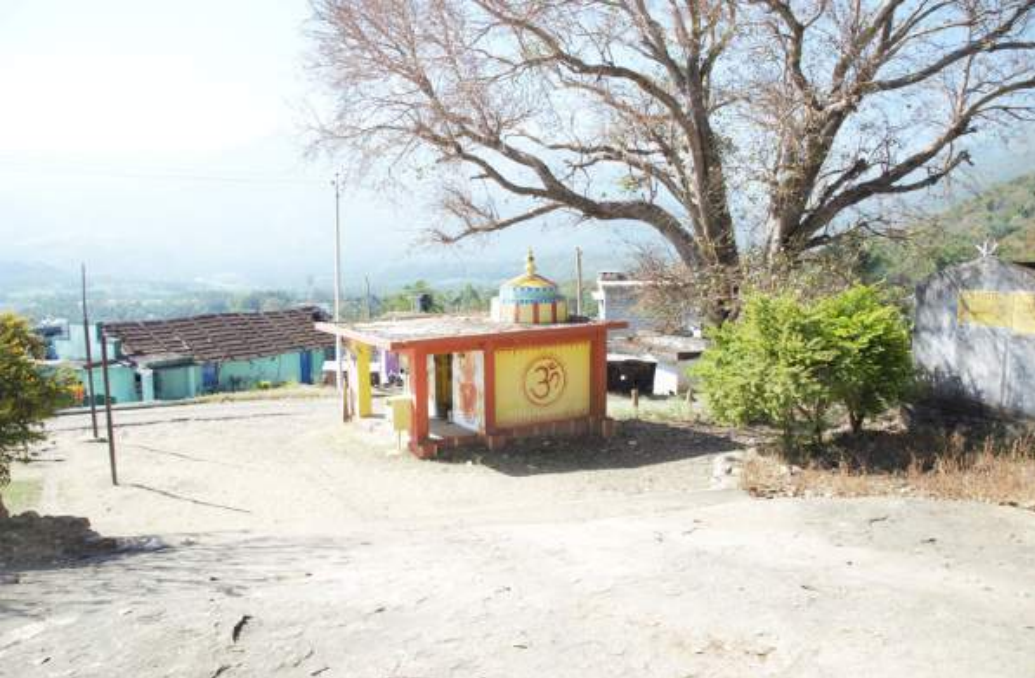
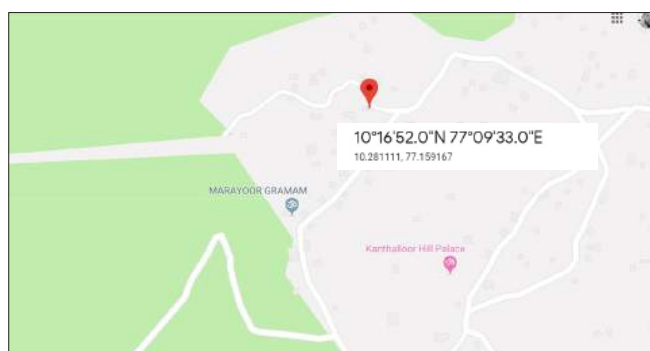
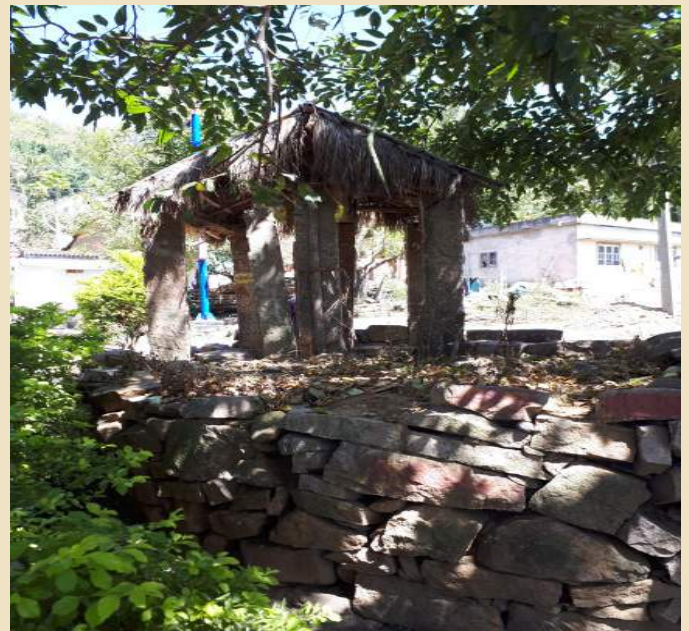
Serial No. - 1	
Name	
Present Name	Village entry
Past Name	Village entry
Any Other Name	
Age of Property	
Precise Date	
Approximate Date	200 - 300 years
Source of Information	Raj Durian
Grade	
Archaeological	I II III
Architectural	I II III
Historical	I II III
Final Grading	I

The site is in fine condition with some signs of deterioration. As there is garbage around, deterioration of stone has also happened with time.

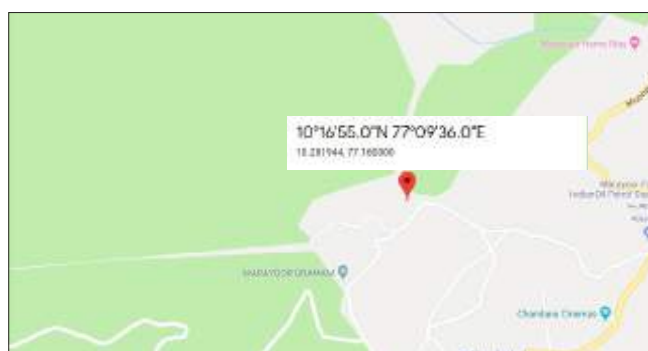
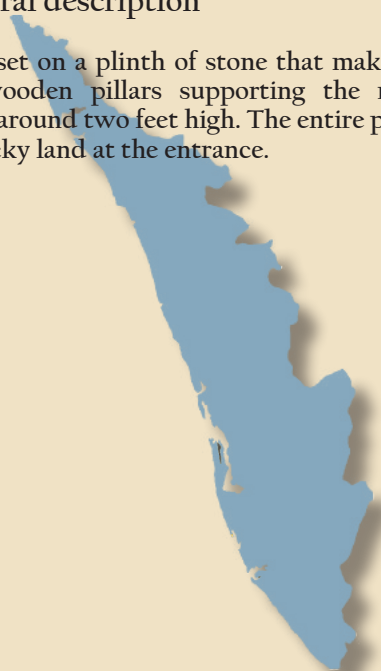
Serial No. - 2	
Name	
Present Name	Hero's stone
Past Name	Hero's stone
Any Other Name	
Age of Property	
Precise Date	
Approximate Date	200 - 300 years
Source of Information	Raj Durian
Grade	
Archaeological	I II III
Architectural	I II III
Historical	I II III
Final Grading	I

The stone is in a fine state. It is protected from sun and water by a small roof.

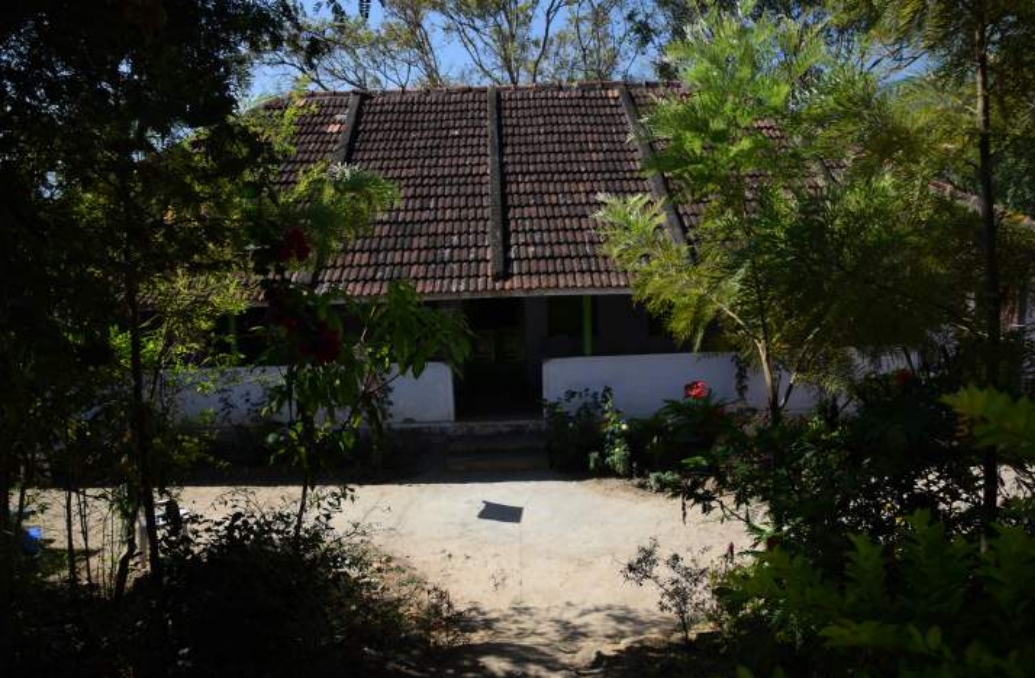
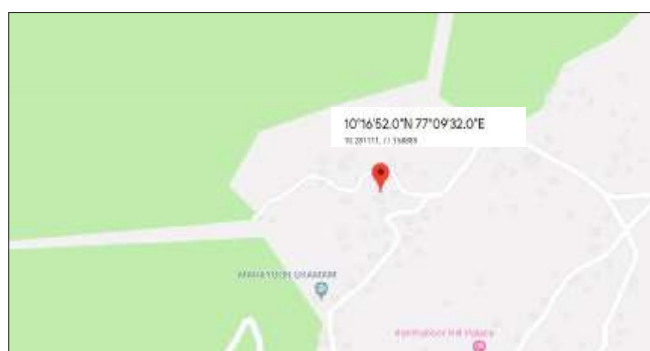
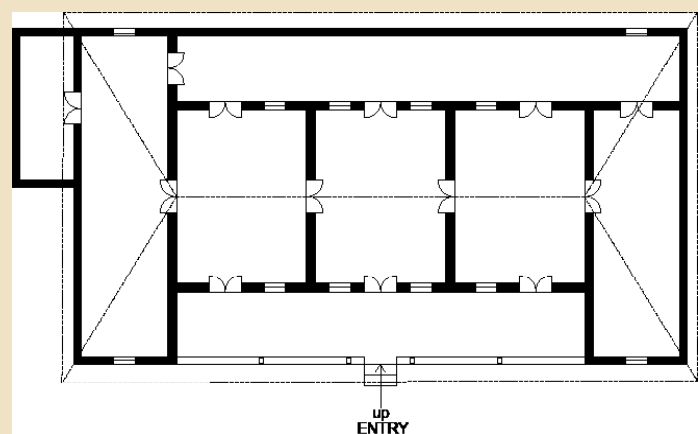
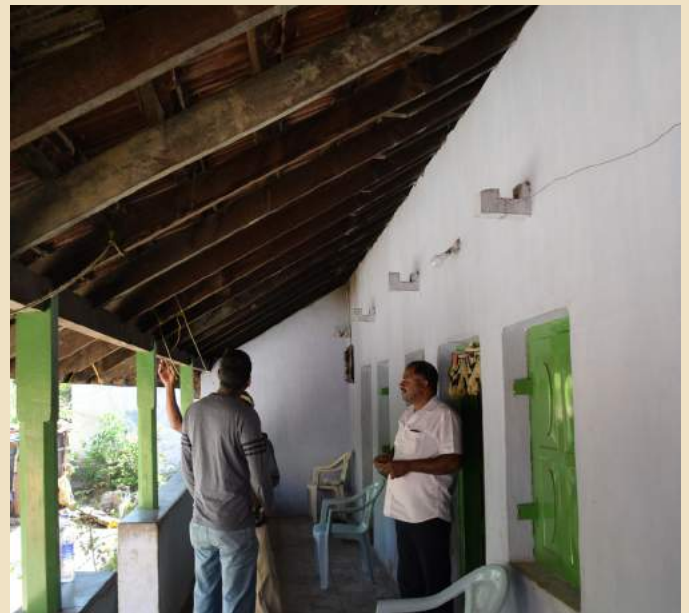
Serial No. - 3	
Name	
Present Name	Perivetttil
Past Name	Perivetttil
Any Other Name	
Age of Property	
Precise Date	
Approximate Date	75 years
Source of Information	Brinda P.S.
Grade	
Archaeological	I II III
Architectural	I II III
Historical	I II III
Final Grading	II A

The structure is showing signs of deterioration with capillary rise in the walls. The internal roof with attic has saged. There is cement repair and the floor has been redone in cement.

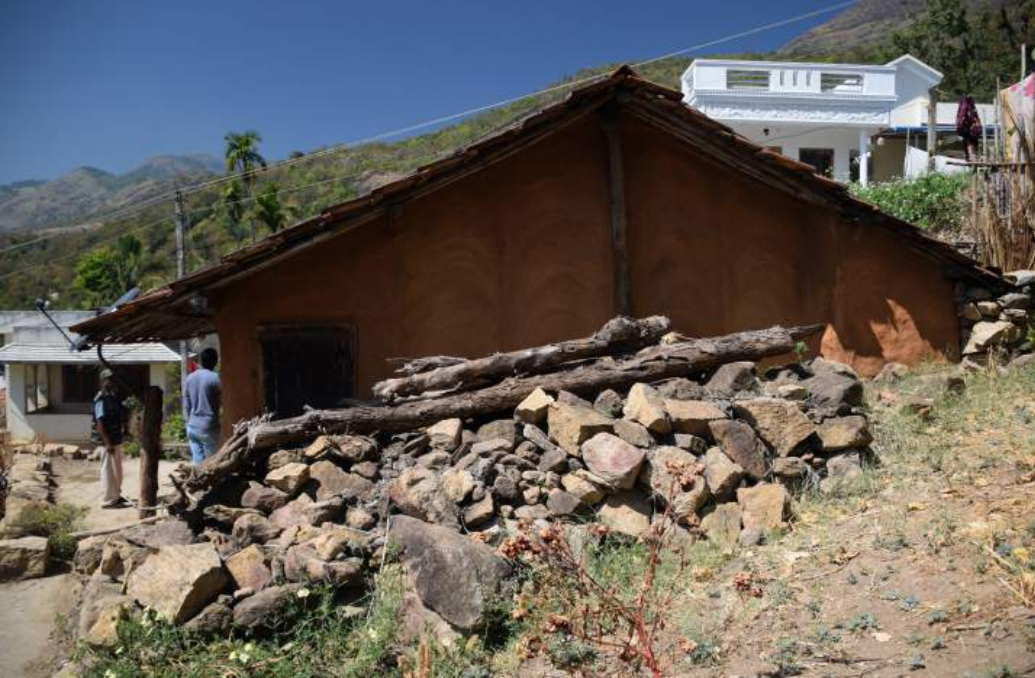
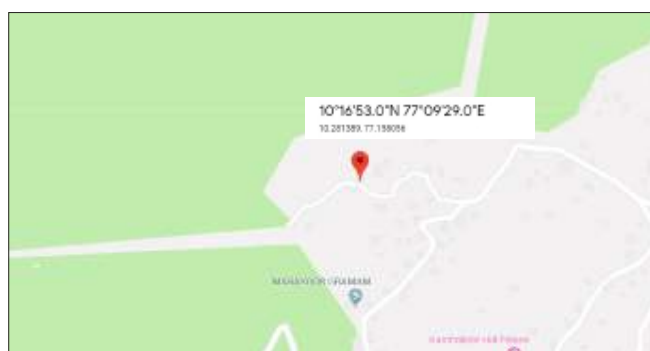
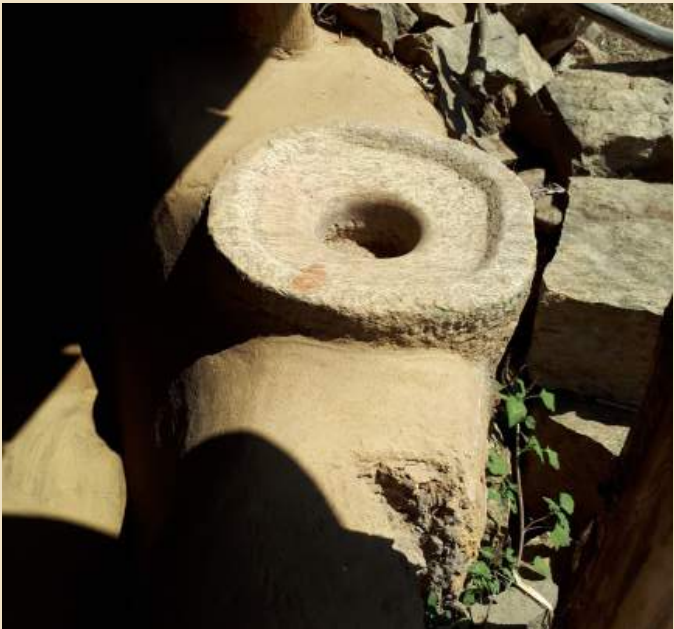
Serial No. - 5	
Name	
Present Name	Pankaj's House
Past Name	
Any Other Name	
Age of Property	
Precise Date	
Approximate Date	80 -- 90 years
Source of Information	
Grade	
Archaeological	I II III
Architectural	I II III
Historical	I II III
Final Grading	II B

Since the structure is in mud, it is well maintained as it needs regular repair and maintenance. The final mud finishing is done every few weeks. At the back, the structure has been covered up with tin sheeting. There is soot deposition in the wood of the roof.

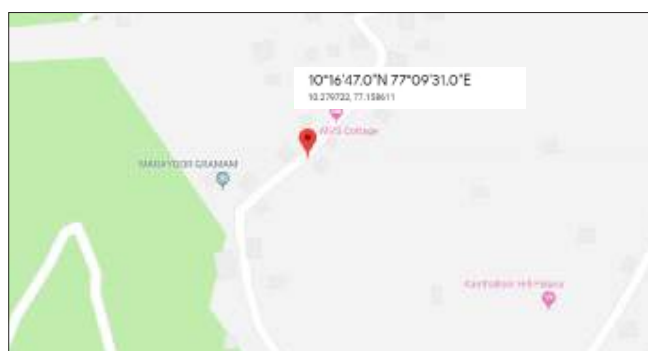
Serial No. - 6	
Name	
Present Name	Unknown
Past Name	Unknown
Any Other Name	
Age of Property	
Precise Date	
Approximate Date	100 years
Source of Information	
Grade	
Archaeological	I II III
Architectural	I II III
Historical	I II III
Final Grading	II

The structure is in a bad state because of negligence. The wood of the windows is getting deteriorated. The tiles on the roof have loosened. Plaster is cracking. The lime wash on the walls is peeling off. The structure is used for storage purpose that has further ruined the condition.

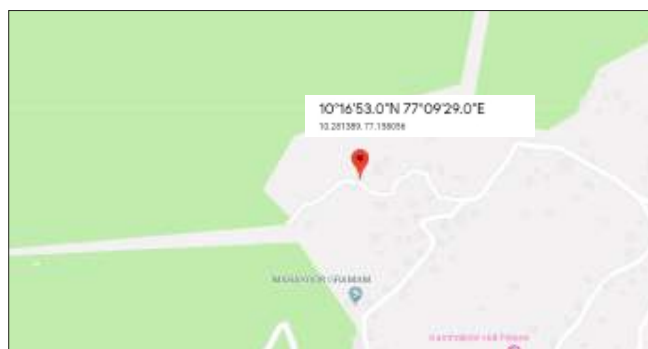
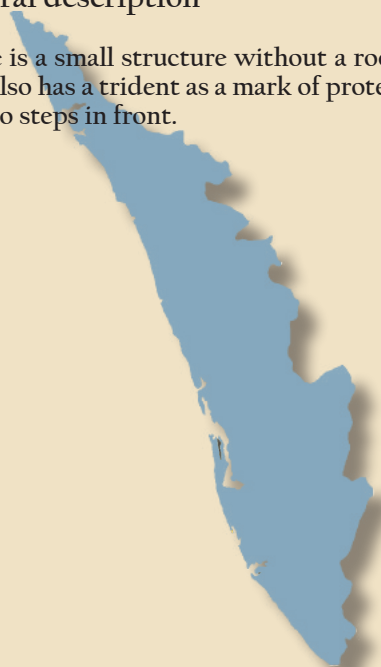
Serial No. - 7	
Name	
Present Name	Temple
Past Name	Not known
Any Other Name	
Age of Property	
Precise Date	
Approximate Date	200-300 years
Source of Information	Raj Durian
Grade	
Archaeological	I II III
Architectural	I II III
Historical	I II III
Final Grading	II A

The structure is in a well-maintained state. It has been limewashed with red trimmings.

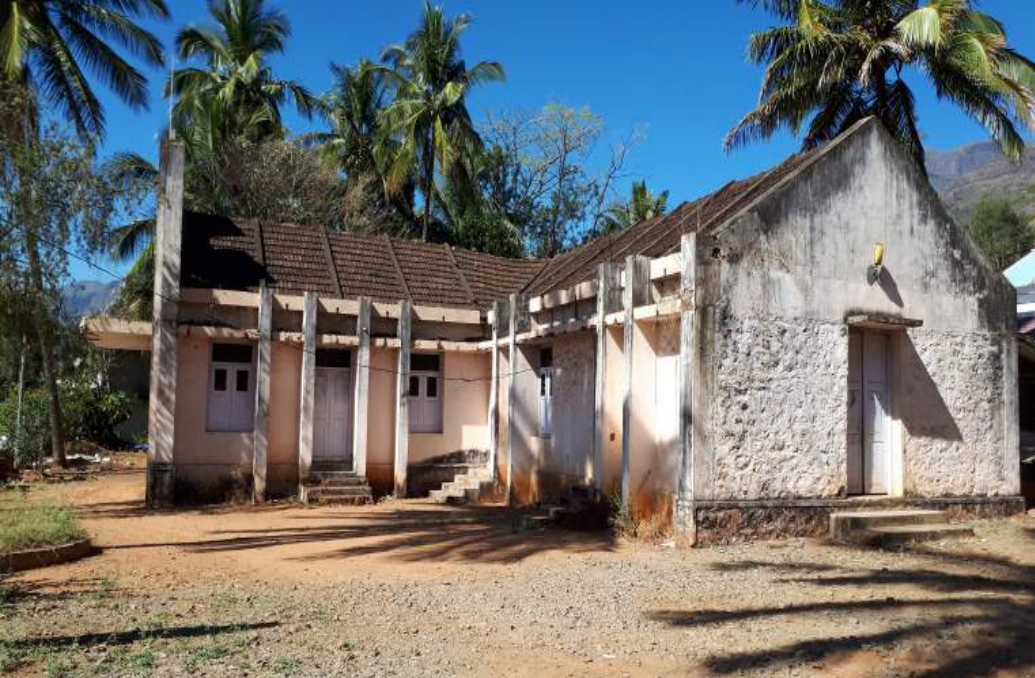
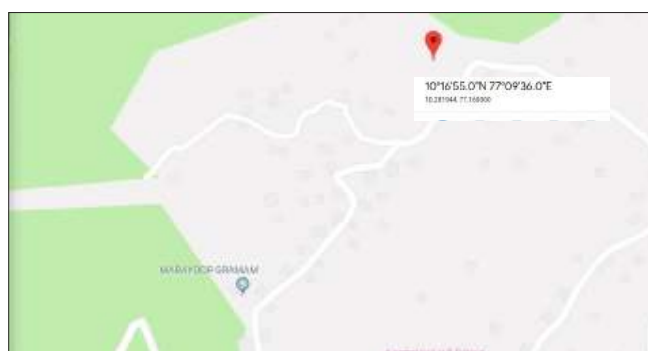
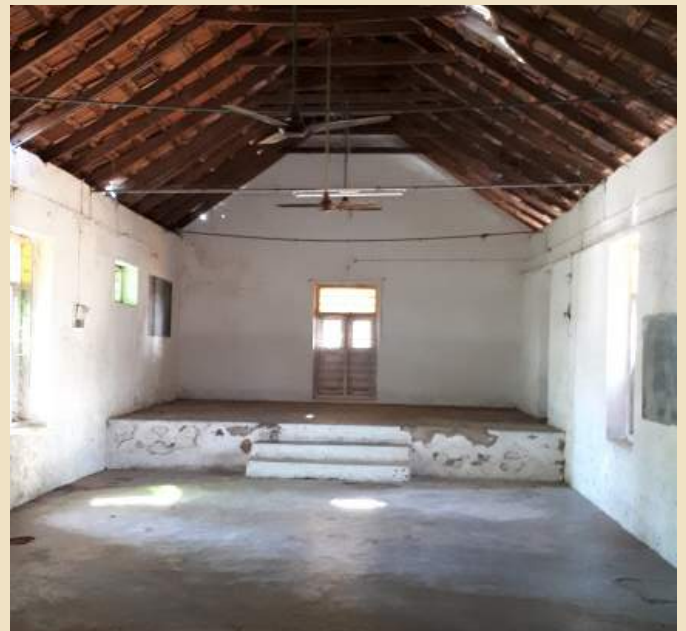
The structure has no use anymore therefore, getting neglected. It has started showing signs of deterioration with dampness on the floor and walls. Internally it has been changed with inappropriate use of new materials.

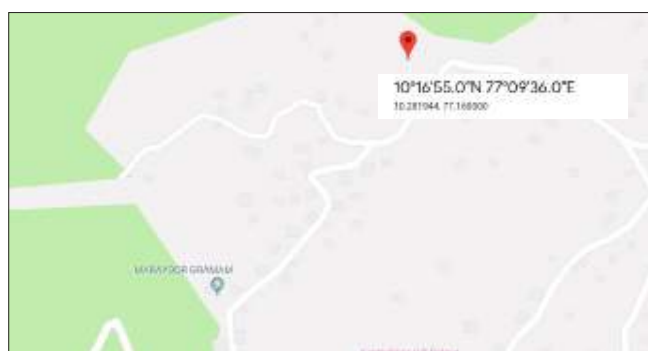
Serial No. - 9	
Name	
Present Name	Gauri Shop
Past Name	Gauri Shop
Any Other Name	
Age of Property	
Precise Date	
Approximate Date	60-70 years
Source of Information	Lakshmi
Grade	
Archaeological	I II III
Architectural	I II III
Historical	I II III
Final Grading	II B

The structure has started showing signs of deterioration. There is dampness in the walls. The floor has been changed with cemented floor and the front steps have been made new in bricks.

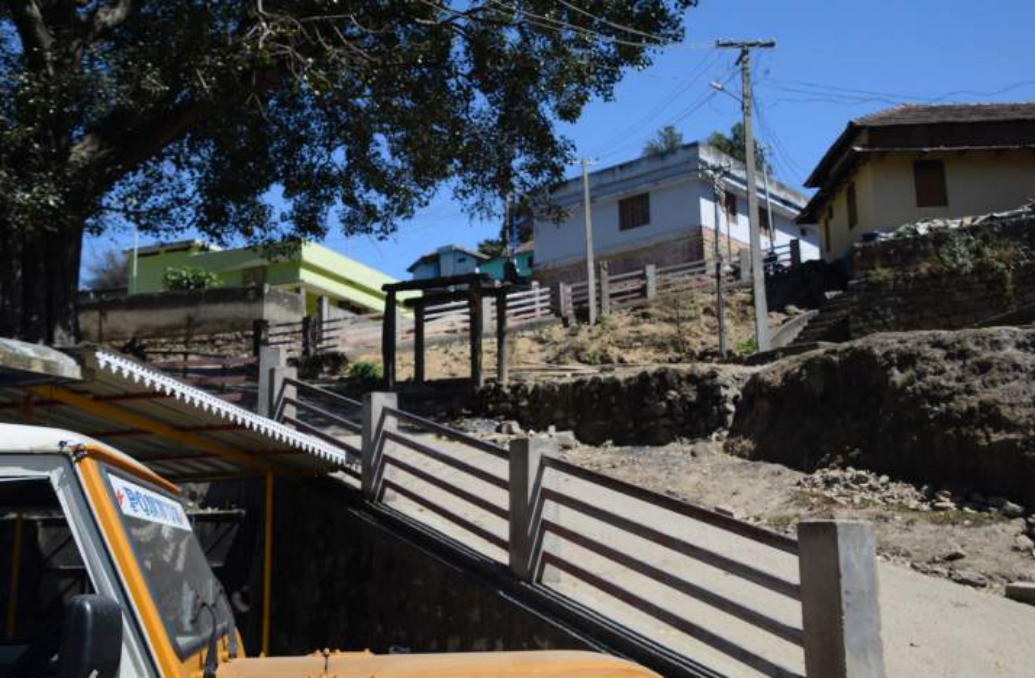
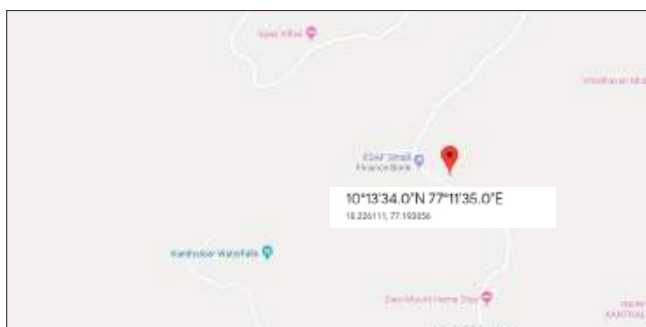
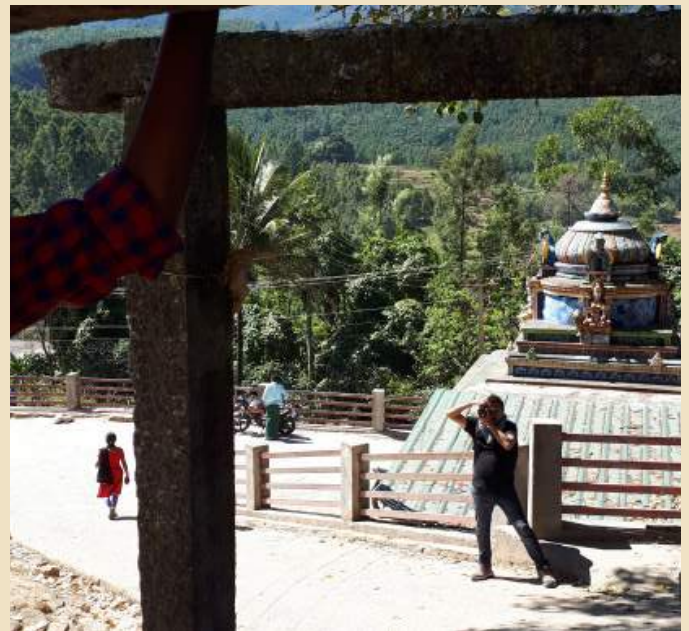
Serial No. - 1		
Name		
Present Name	Entry to the village	
Past Name	Entry to the village	
Any Other Name		
Age of Property		
Precise Date		
Approximate Date	200-300 years	
Source of Information		
Grade		
Archaeological	I	II III
Architectural	I	II III
Historical	I	II III
Final Grading	I

The gateway structure has started deteriorating with loose joints. The steps in front of the gateway are also in a deteriorating state due to negligence. A new road has been added that goes through the entire set up leaving the temple and tree on one side and gateway on the other. The temple has been repaired and added with top decorations, making it look entirely new.

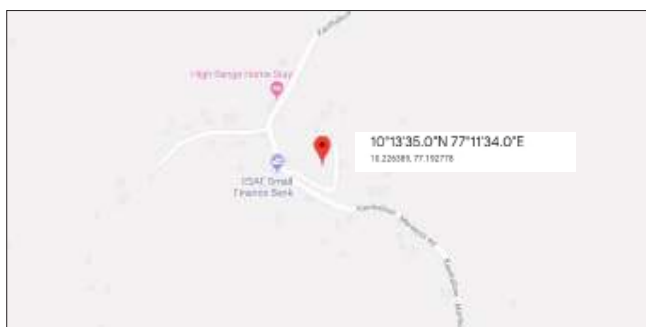
The structure is showing signs of deterioration with mud plaster cracking and falling off. The wooden and bamboo beams and rafters are rotting due to seepage and no main-tenance. Terracotta tiles have moss deposition.

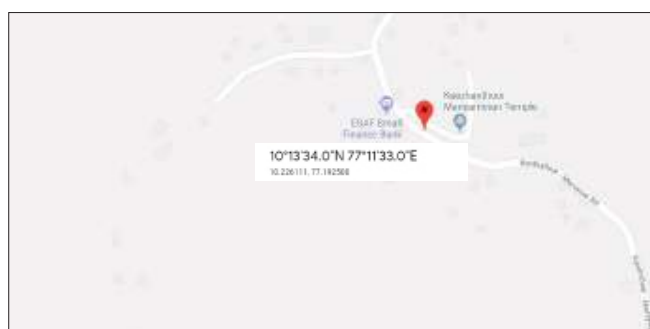
The structure has started showing signs of deterioration. It has been repaired in cement. Flooring has also been changed to the cement floor. Walls are regularly lime-washed. The floor has been cemented and cemented steps have been added. There is a capillary rise visible in the plinth.

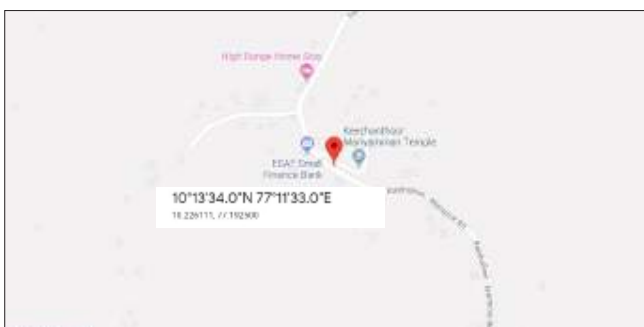
The mud walls and floor of the structure are well maintained as it is repaired on a regular basis. The entrance steps on one side are getting loosened. The roof is in deteriorating condition with soot deposition and moss deposition.

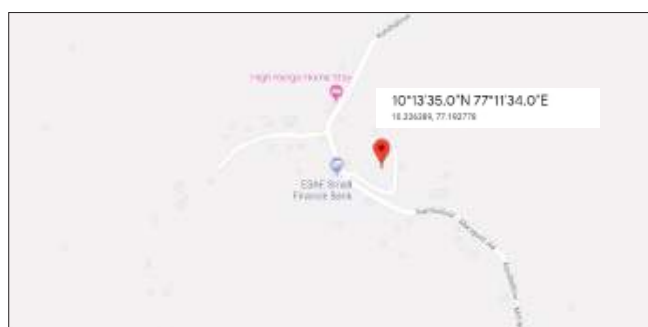
The mud walls of the structure are well maintained as it is repaired on a regular basis. There is soot deposition in the roof and moss deposition in tiles. The structure has been repaired with cement in a few places.

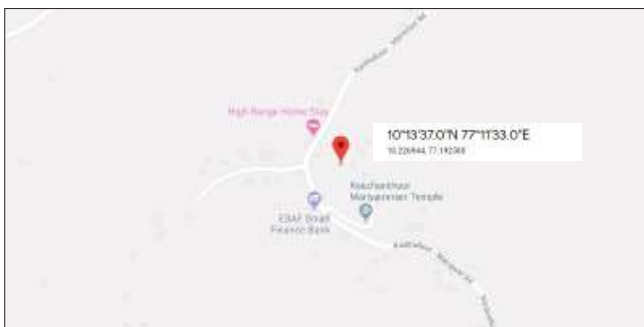
The structure has been repaired in cement. In most of the places, the floor has been changed to cemented floor. The walls are regularly whitewashed. The tiles and wood in the roof have soot deposition.

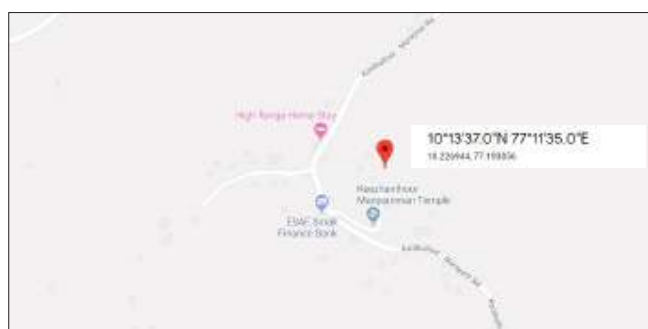
The structure is in good condition. There are some changes that have been made to the original structure like enclosing of the verandah.

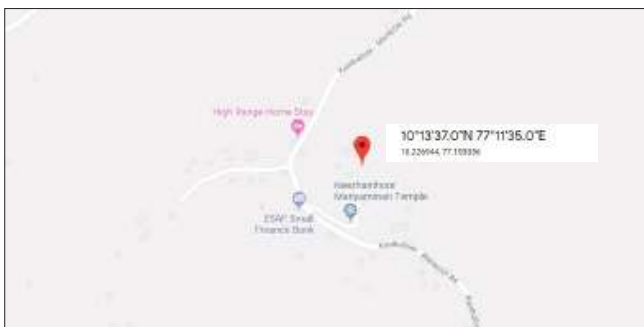
The structure is in a fine condition with few signs of deterioration. It has been whitewashed with lime. The wood in the roof is not maintained thereof has started rotting.

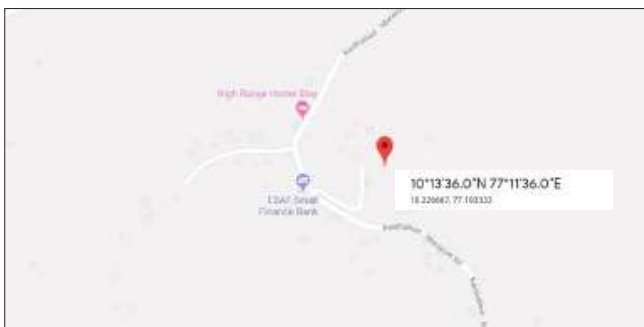
The structure is in fine condition. it has been lime washed regularly. There is a small extension at the back. The roof has soot deposition because of the kitchen. Because of soot and dampness from top the attic is in deteriorating state.

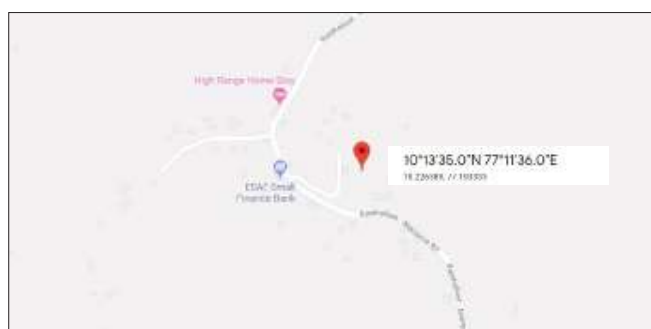
The structure is in well-maintained condition. It has been lime washed regularly. The roof has a broken drain pipe and soot deposition.

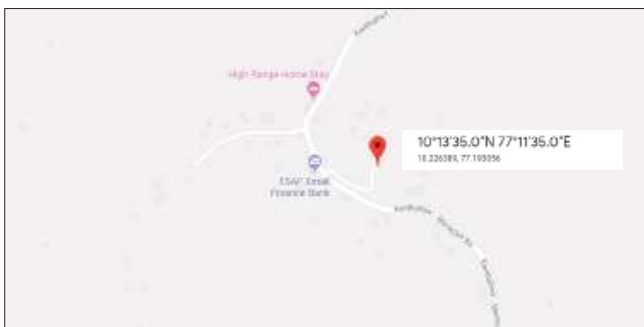
The structure is in fine condition with few signs of deterioration. The structure has the capillary rise in the walls that have caused plaster to flake and bricks to rot in a few places. The attic is not so well maintained with dust deposition everywhere.

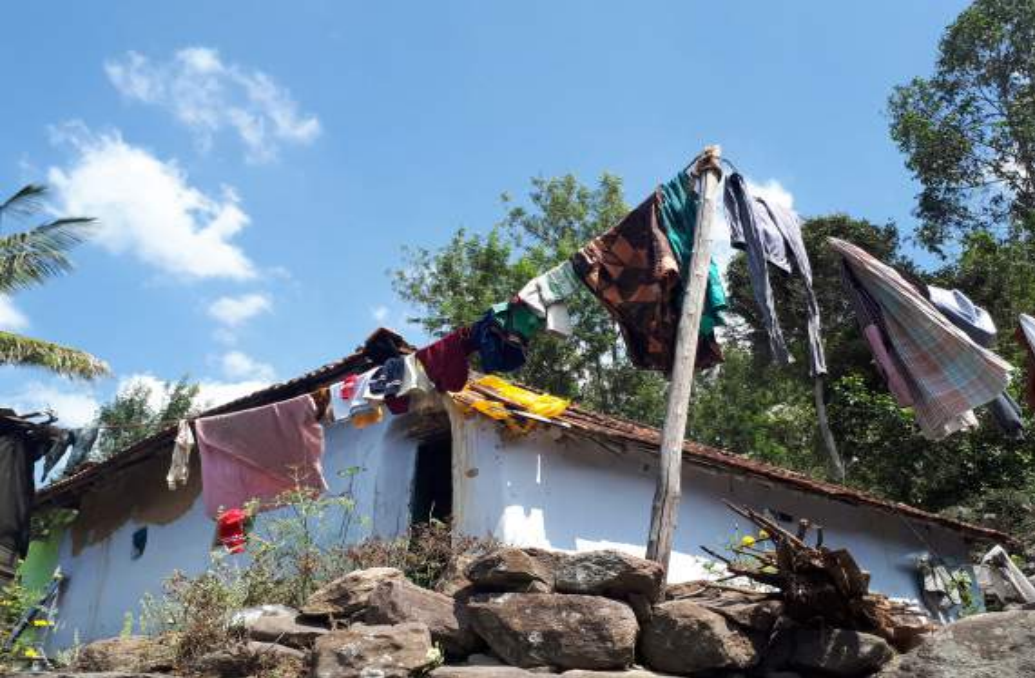
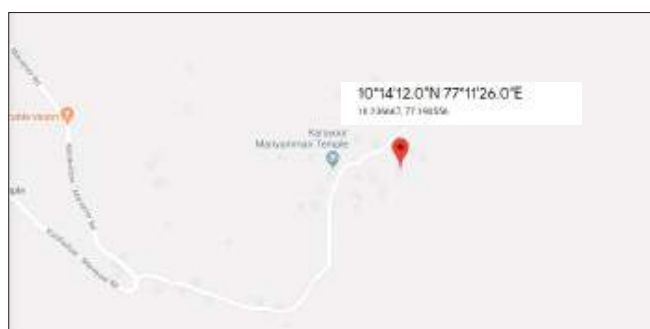
The front verandah of the structure has been modified and arches have been added. Another small room towards outside next to the verandah is also later addition. The white-wash from the structure is falling off. There is a capillary rise in the walls and wooden members in the roof are in deteriorating condition due to soot deposition and seepage.

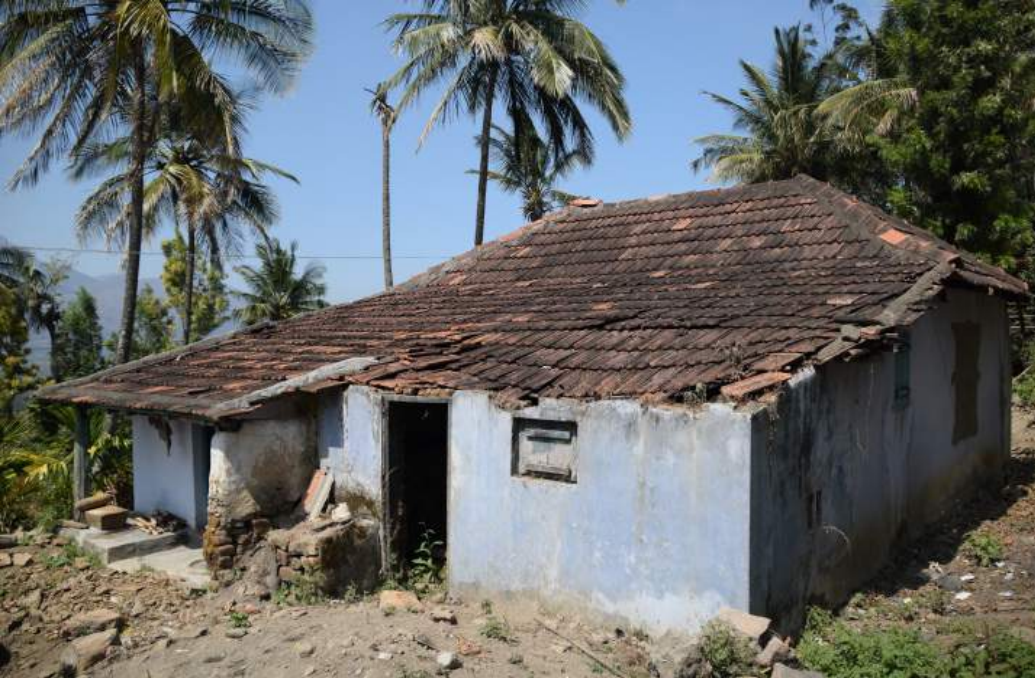
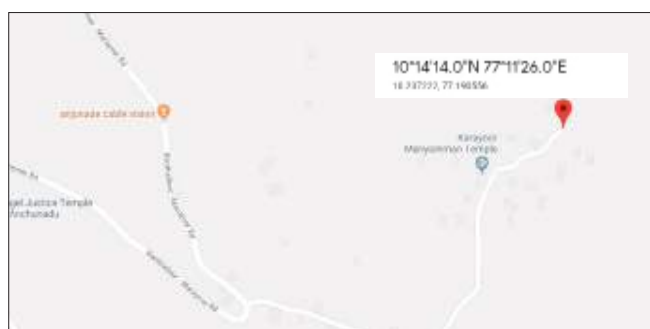
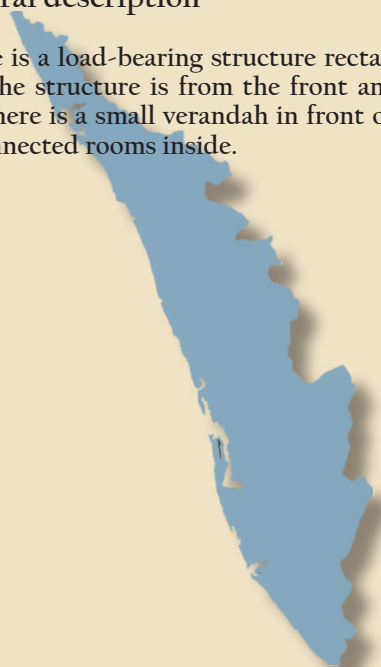
The structure is an abandoned structure with missing doors. There is seepage and capillary rise in the structure. Wooden windows are in deteriorating condition.

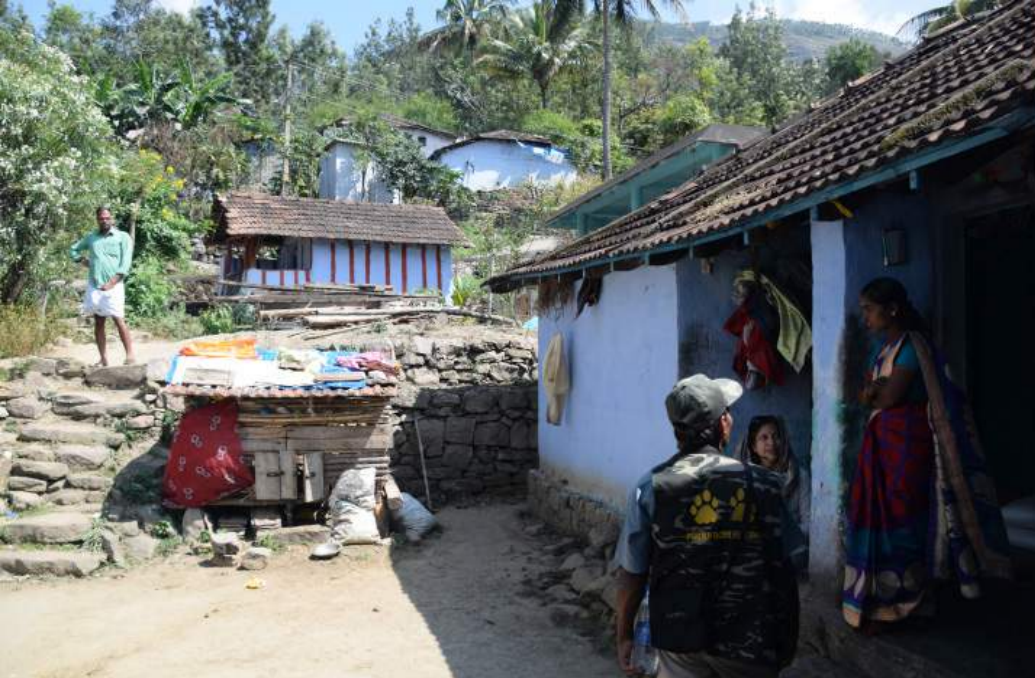
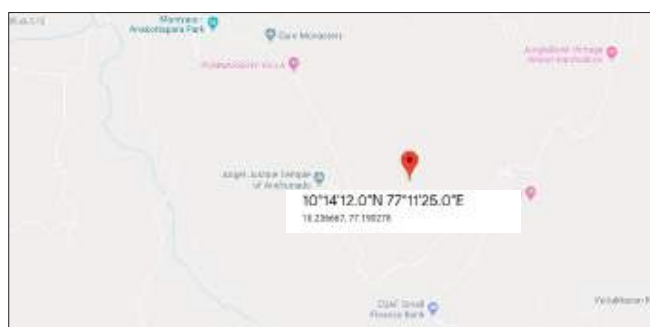
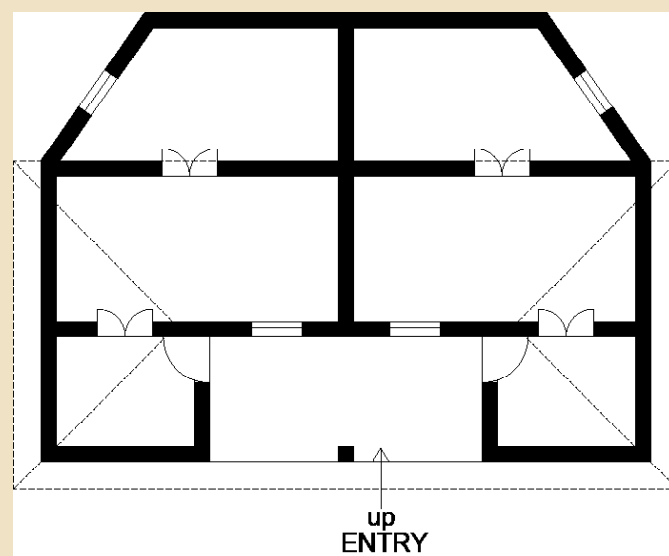
The structure is in a well-maintained condition. Outside is limewashed regularly and inside is re-laid with mud. The only roof shows sign of negligence. There is soot deposition on the wood and terracotta tiles in the roof. The floor has been redone cement.

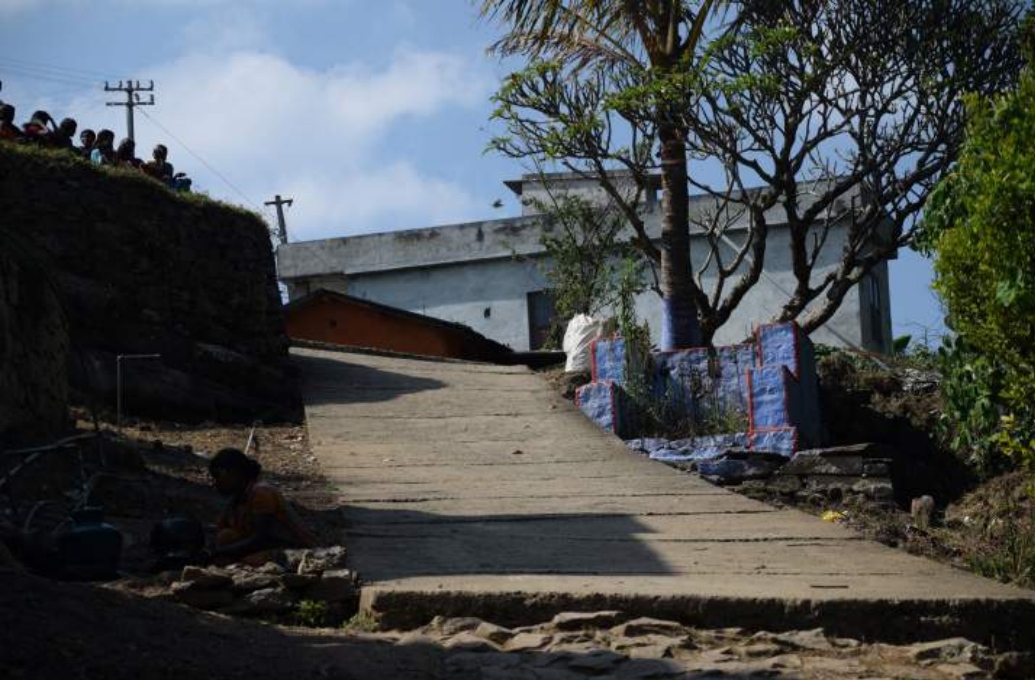
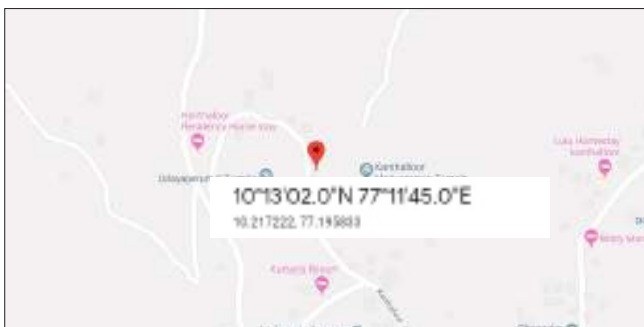
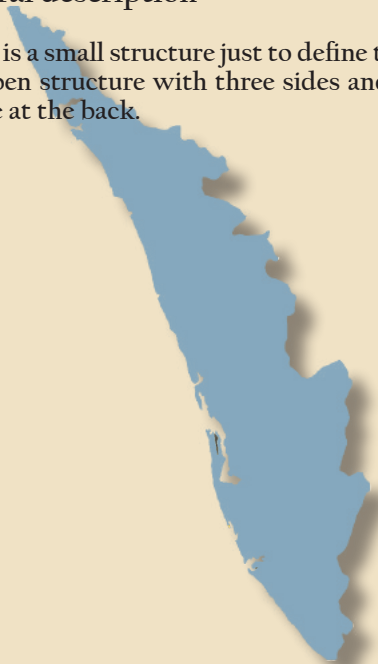
Structure is in a good condition as it is maintained and lime washed regularly.

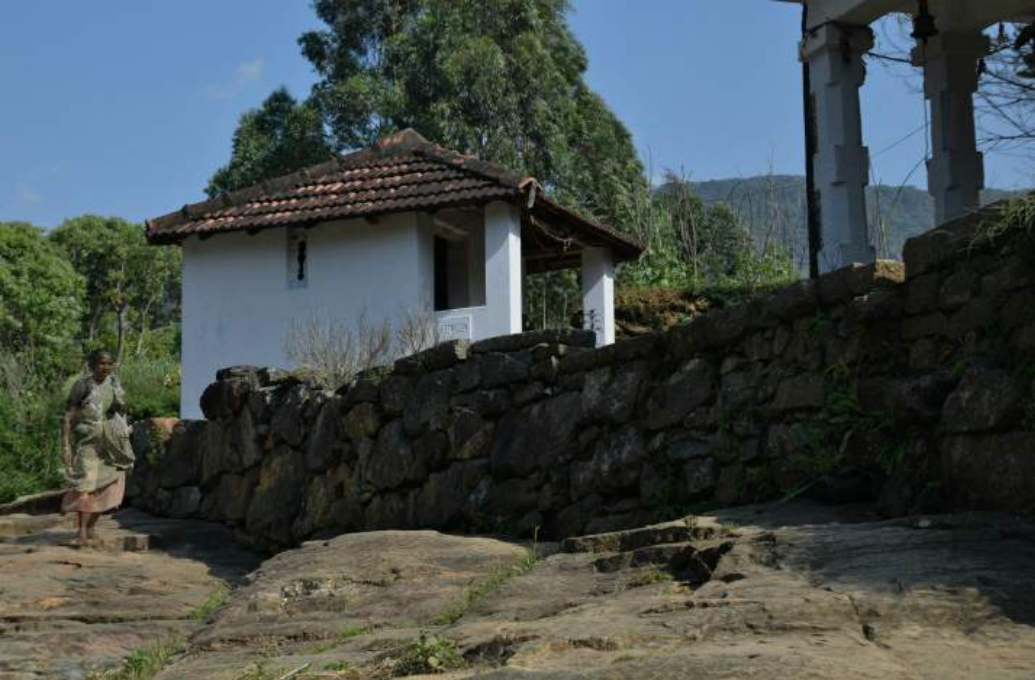
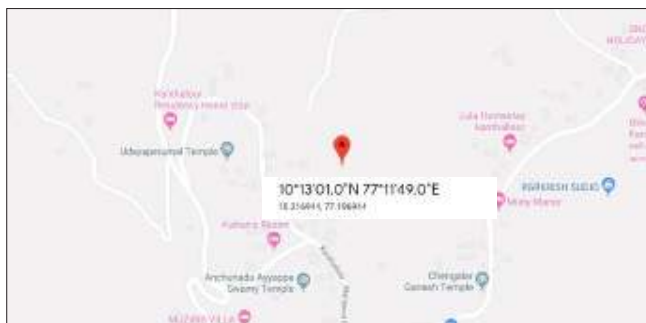
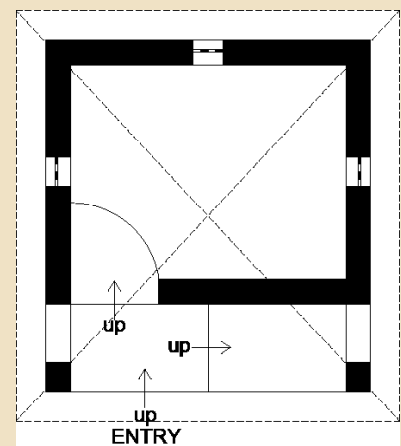
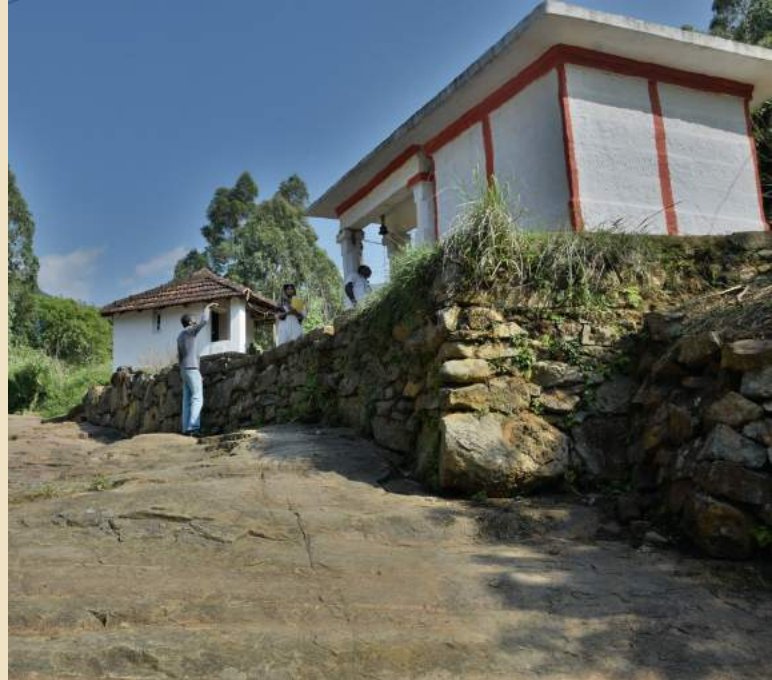
The structure has been maintained well. The walls have been whitewashed but there are signs of capillary rise. The roof has moss deposition that has turned dark with time.

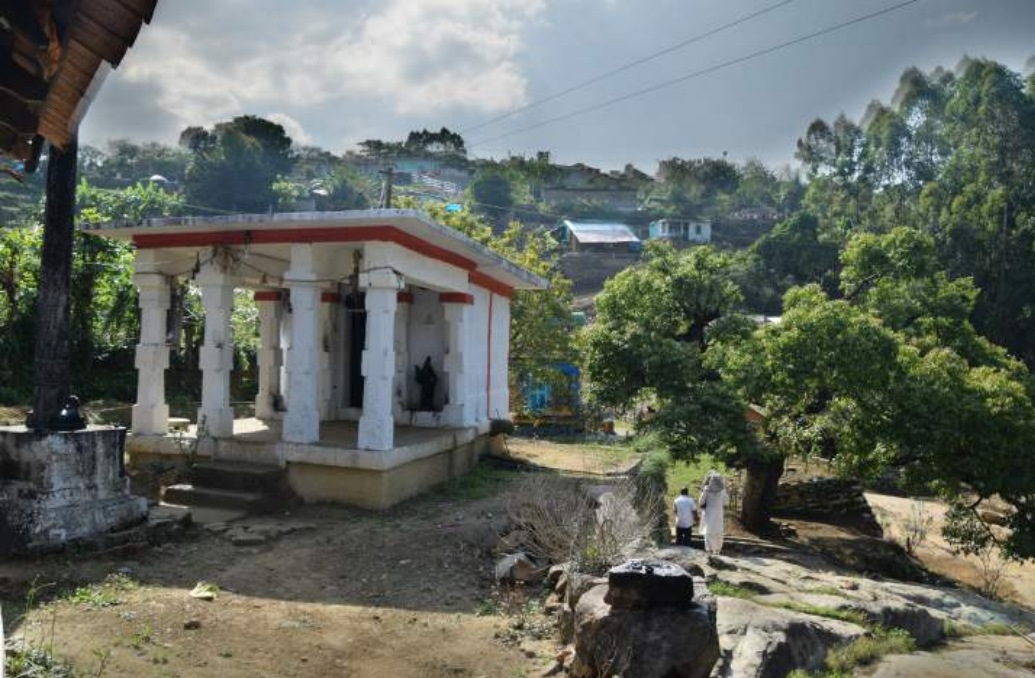
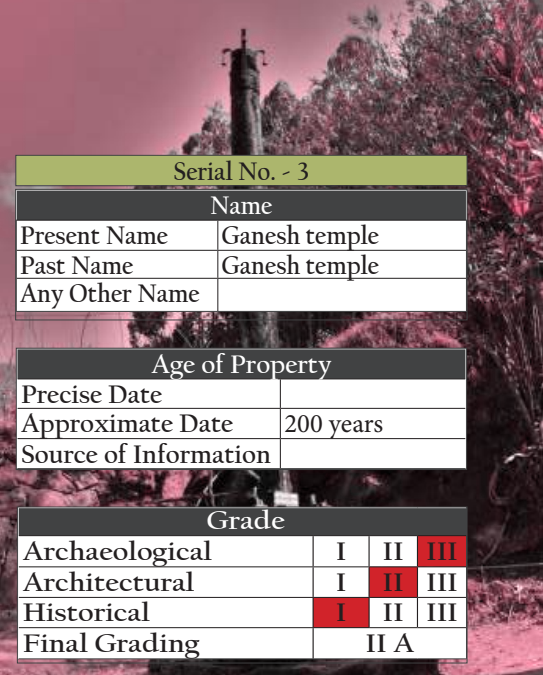
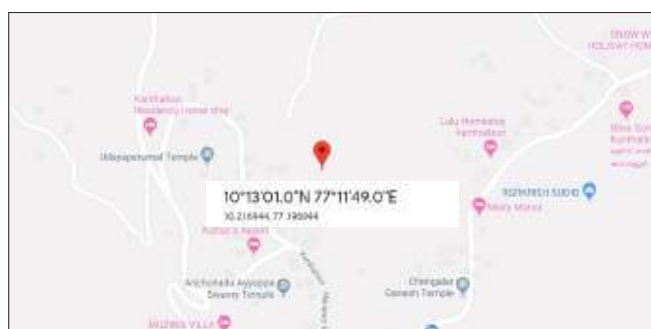
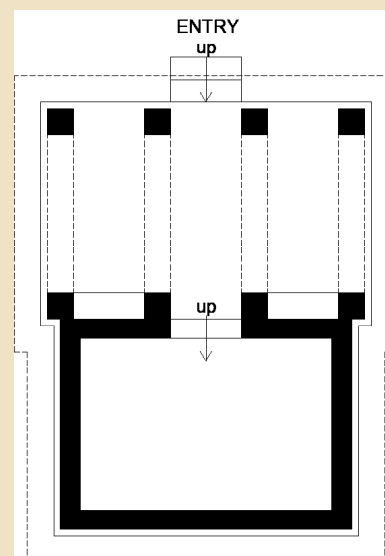
There is soot deposition in some areas and deterioration due to water otherwise well-maintained structure. All whitewashed directly on stone.

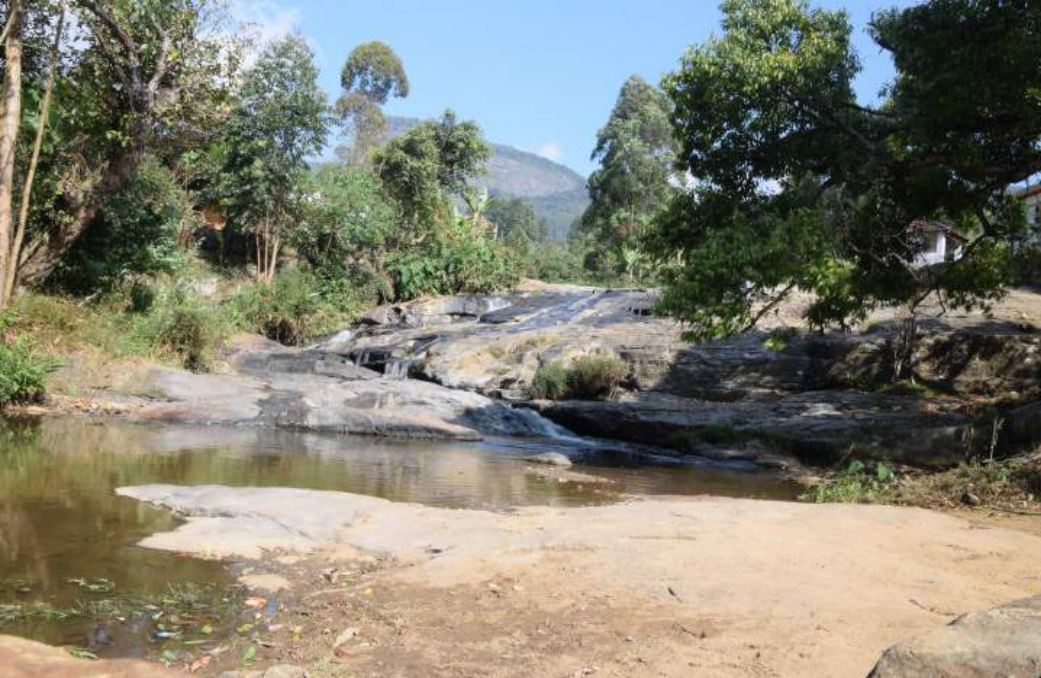
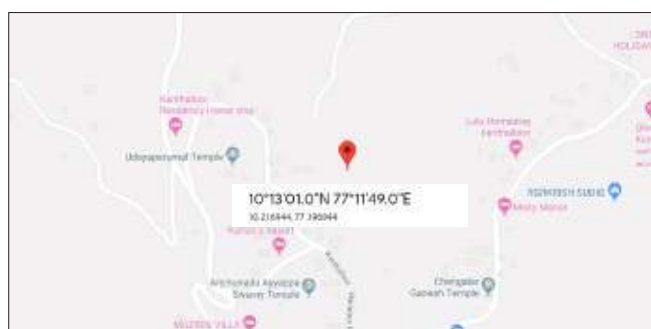
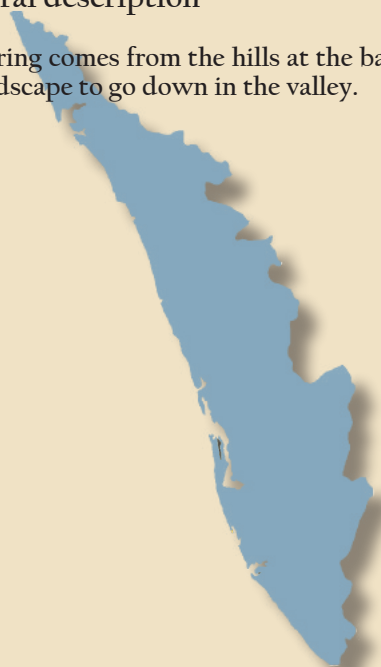
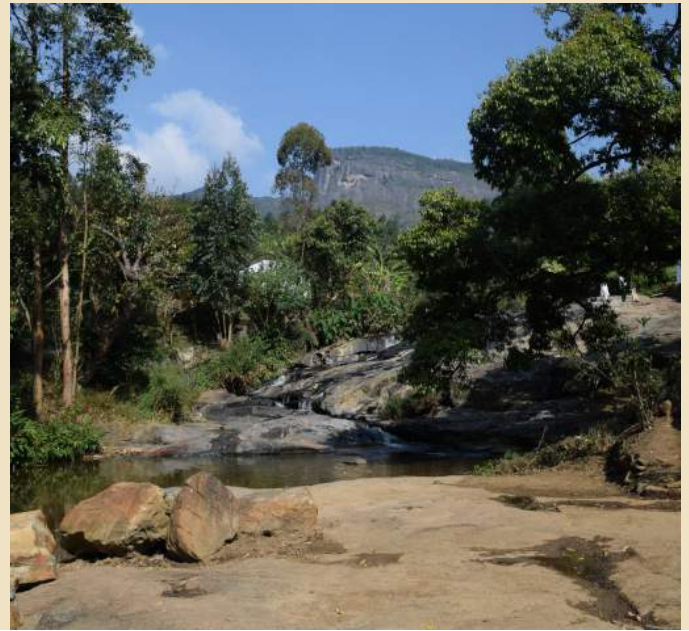
There are plastic bags and filth around the edge of the waterbody as people bathe and wash clothes and leave the waste next to the waterbody.

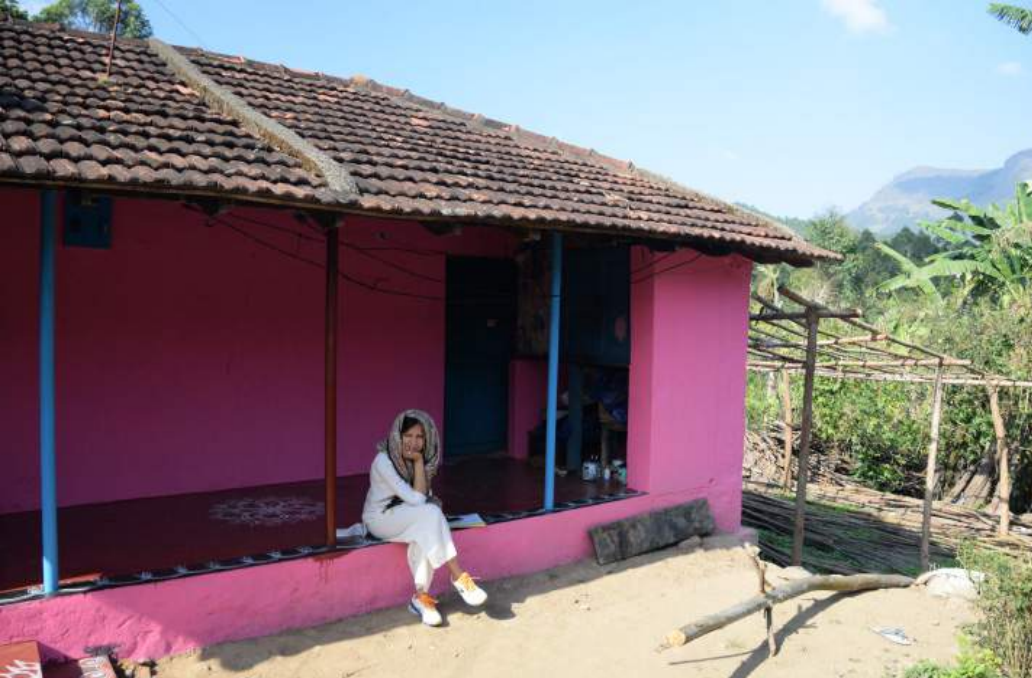
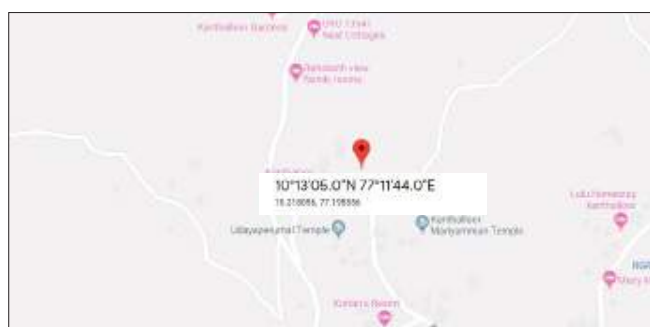
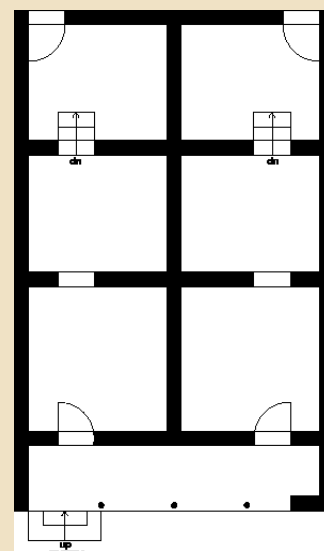
The structure is in good condition as it looks recently repaired in cement. The floor has been cemented and painted.
