A PLAN FOR **RURAL TOURISM**
WITH DOCUMENTATION OF HERITAGE IN **ANJUNAD REGION OF KERALA**

Preeti Harit Design

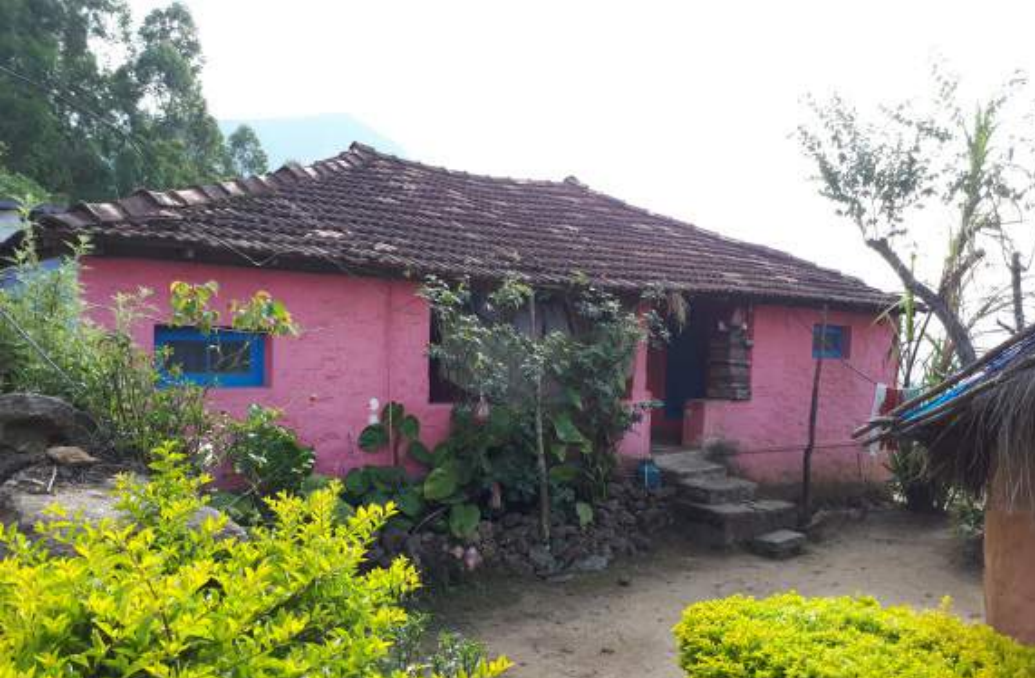
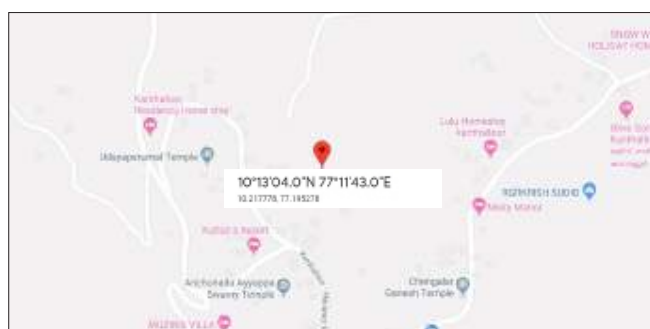
The structure is generally in a good state with colored lime wash. It has been repaired in cement in a few places. There is capillary rise in the walls.

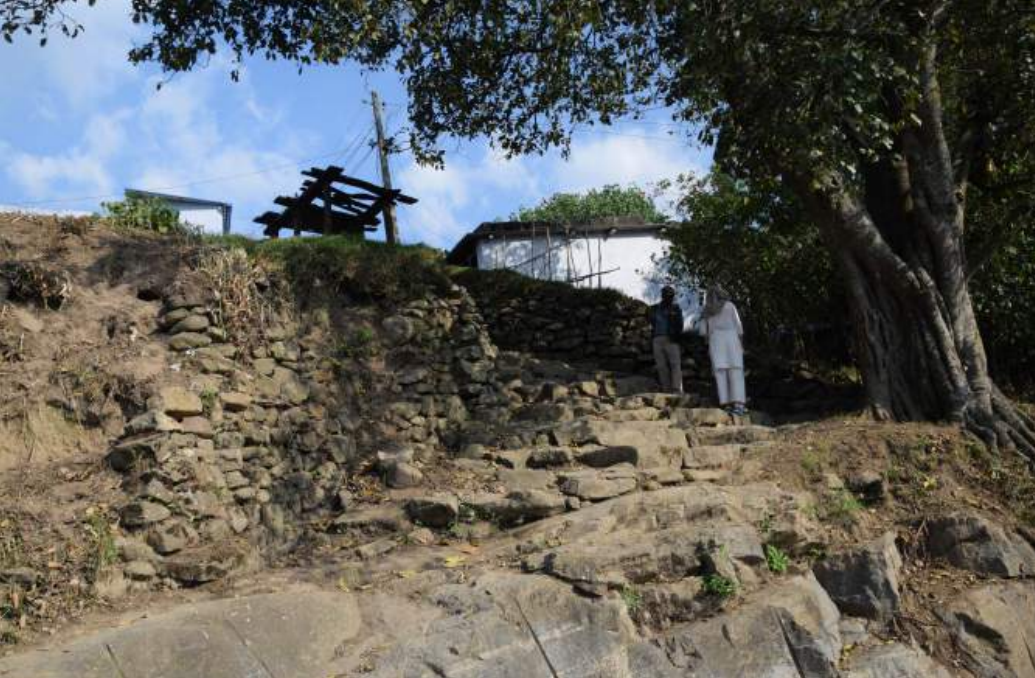
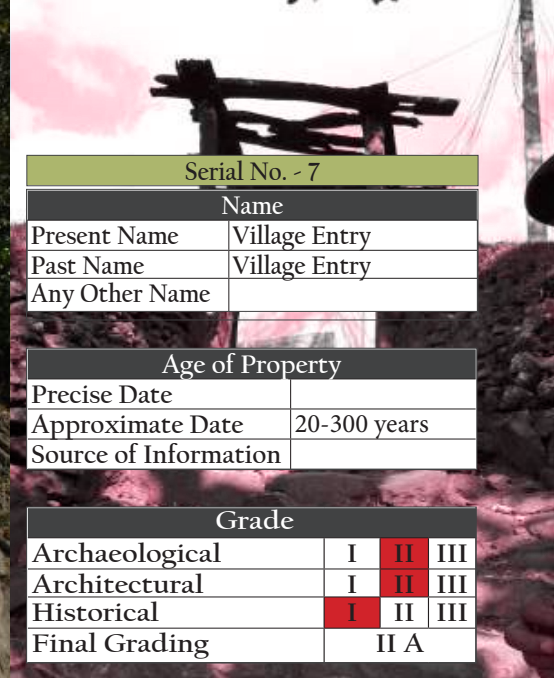
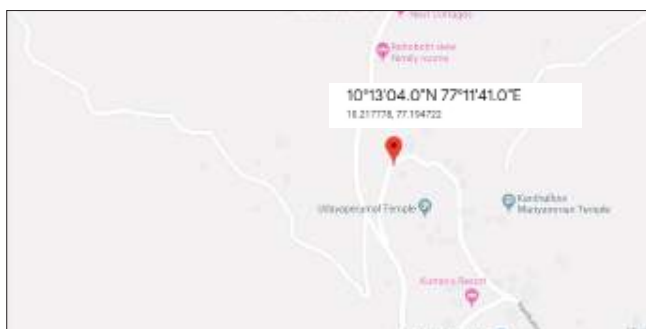
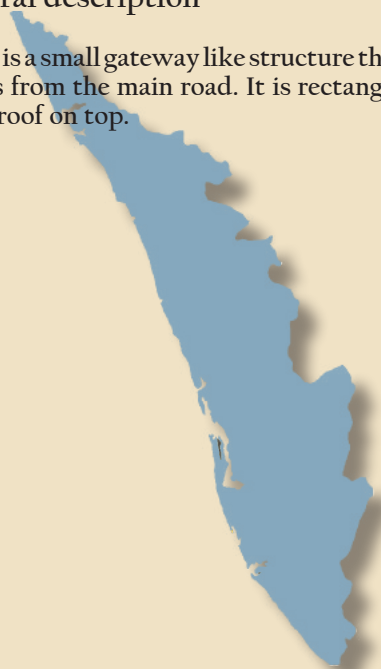
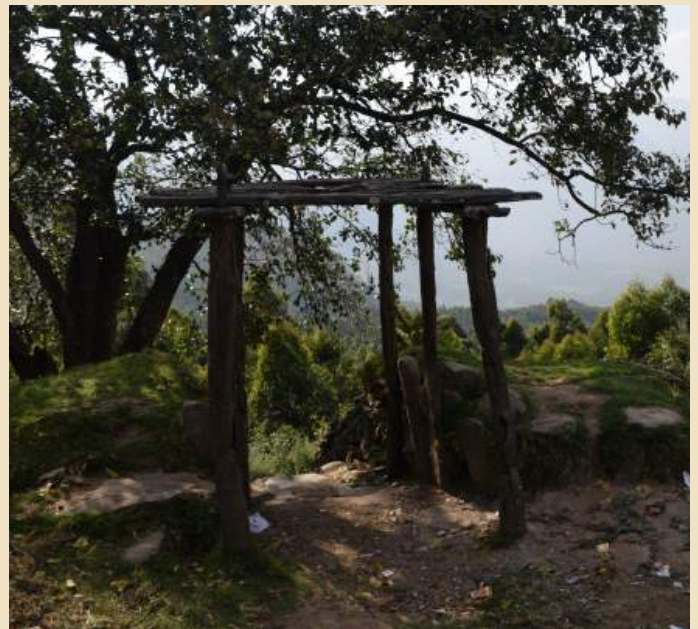
The structure is in a bad state with rotting wooden columns and roof. The steps in front are broken and unkept. The entry has no use therefore, the site is neglected. One of the main features that is the temple at the entrance is not there anymore.

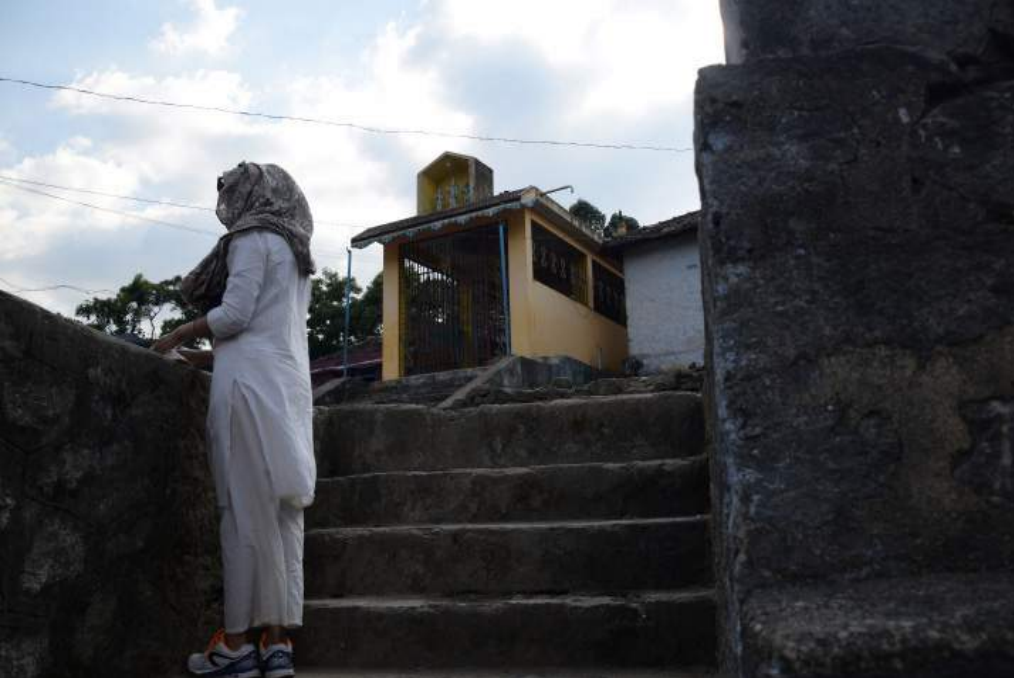
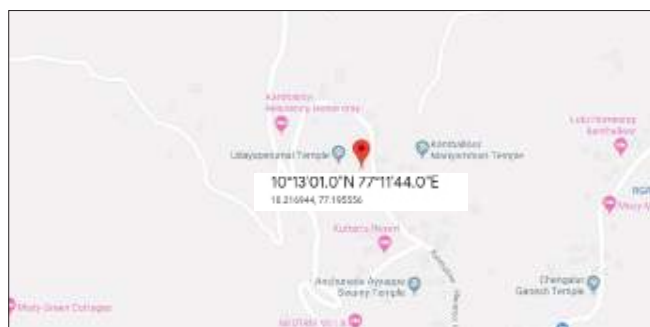
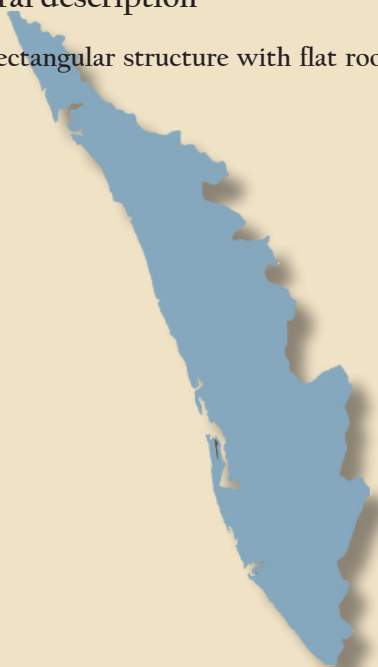
Serial No. - 8	
Name	
Present Name	Maha Vishnu Temple
Past Name	Maha Vishnu Temple
Any Other Name	
Age of Property	
Precise Date	
Approximate Date	50 years
Source of Information	
Grade	
Archaeological	I II III
Architectural	I II III
Historical	I II III
Final Grading	III

The structure has been well maintained with regular repair work. It has been repaired in cement with cemented steps and lime wash on walls. New metal gate and grills have been added in the openings.

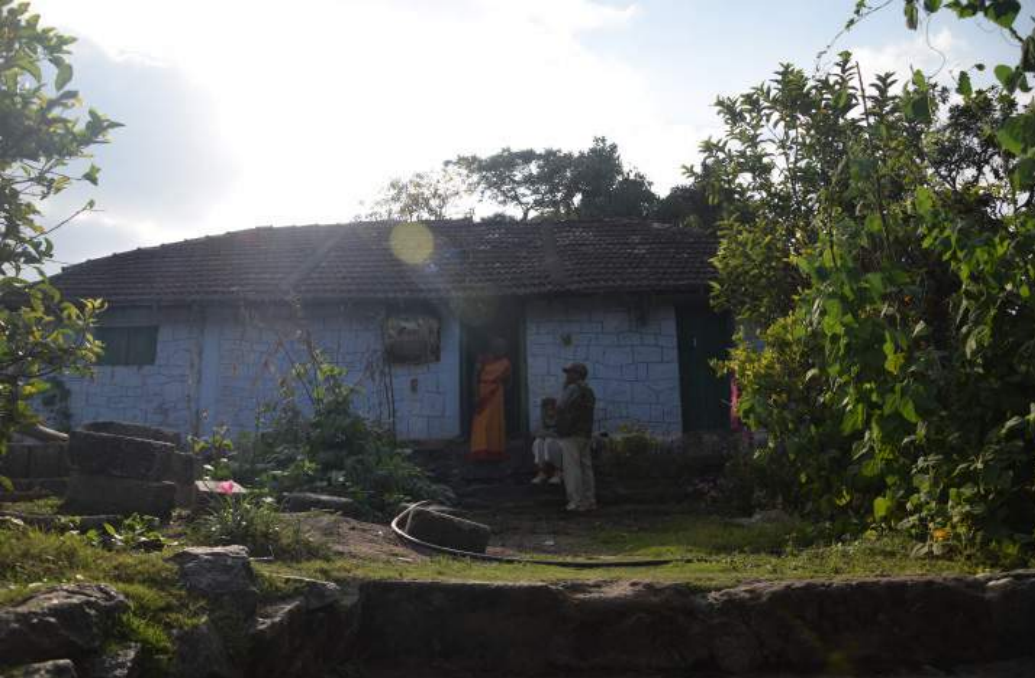
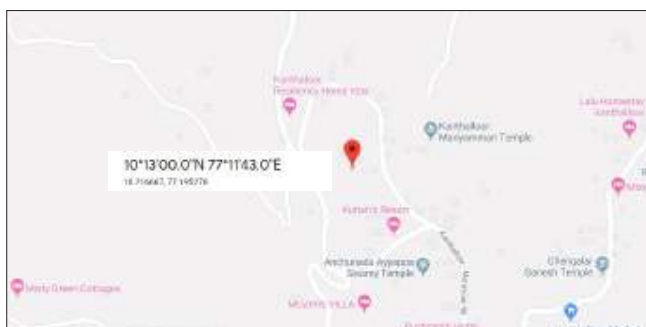
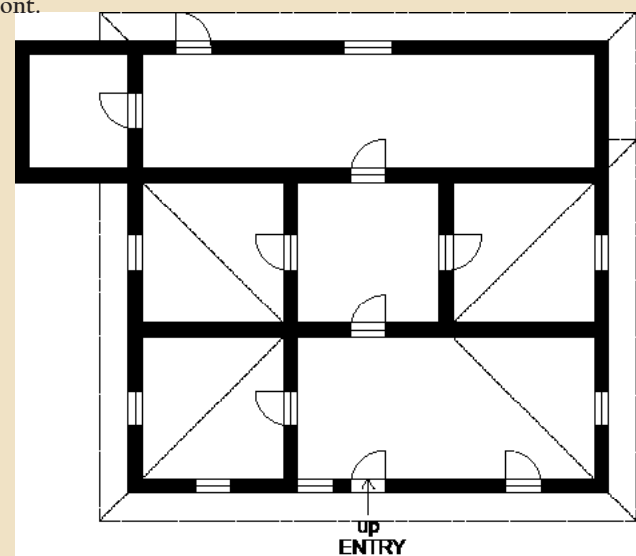
The structure though lime washed from outside is showing signs of deterioration with capillary rise in the walls. There is soot deposition in the roof and wooden members are getting deteriorated because of negligence.
